Evaluation of light-curing units tips used in the clinic of a dental school

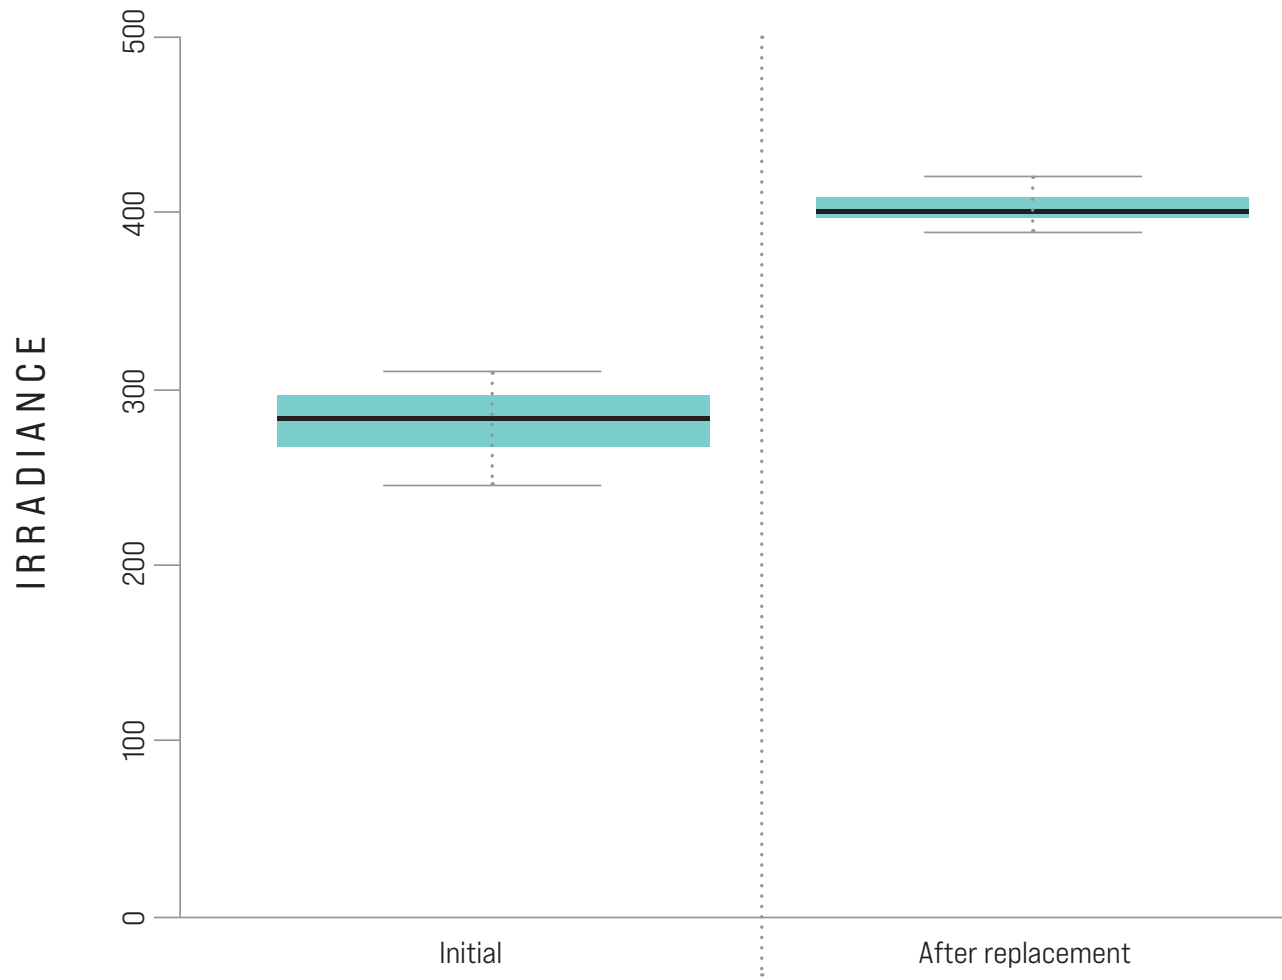
It is observed in Table 1 and Figure 1 that there was a significant increase in irradiance ($p < 0.05$) after replacing all the tips of the devices. In Figure 2, it can be seen that 30% of the tips had debris, 30% cracks, 30% fractures and 10% had debris and cracks.

Figure 1: Box plot of the irradiance of the light curing tips used in the clinic of a dental school in the initial times and after the exchange.

According to the results found in this study, all 20 devices used in the clinic of the Faculty of Dentistry had some kind of deterioration of the tip, be it with the presence of debris, fractured, cracked and / or with debris and cracked, simultaneously.^{11,12} The evaluation in table 1 shows that the devices initially presented a significant variation in the irradiance values, since the standard deviation was 17.61, that is, the difference between the maximum (310 mW/cm²) and minimum (245 mW/cm²) were of

great amplitude (Fig 1). When the tips were replaced, the standard deviation dropped dramatically, causing a statistically significant difference ($p < 0.0001$). This shows that these devices were operating below the expected standard and, only after replacing them, did the irradiance meet the minimum values suggested by the literature.¹² These data are in agreement with the study by Miranda et al,¹³ which justifies that the presence of restorative materials in the light tip is able to reduce the irradiance emitted by the device, causing a possible underpolymerization of restorative materials. Underpolymerization can cause color change, greater porosity, decreased adhesion to dental tissue, greater wear, deterioration of its mechanical and physical properties, in addition to insufficient polymerization of the deeper layers which also contributes to microleakage, increasing the index of post sensitivity-operative and restoration failures.⁷

study, after replacing all tips, the average irradiance was $402.1 \text{ mW} / \text{cm}^2$, which means a real increase of around 69.82%. Thus, after replacing the tips, the devices could be used with greater safety in the dental clinic, ensuring better results in the adhesive procedures, provided that a minimum photo-activation time of 40 seconds is used, so that a 16J of power.¹⁷

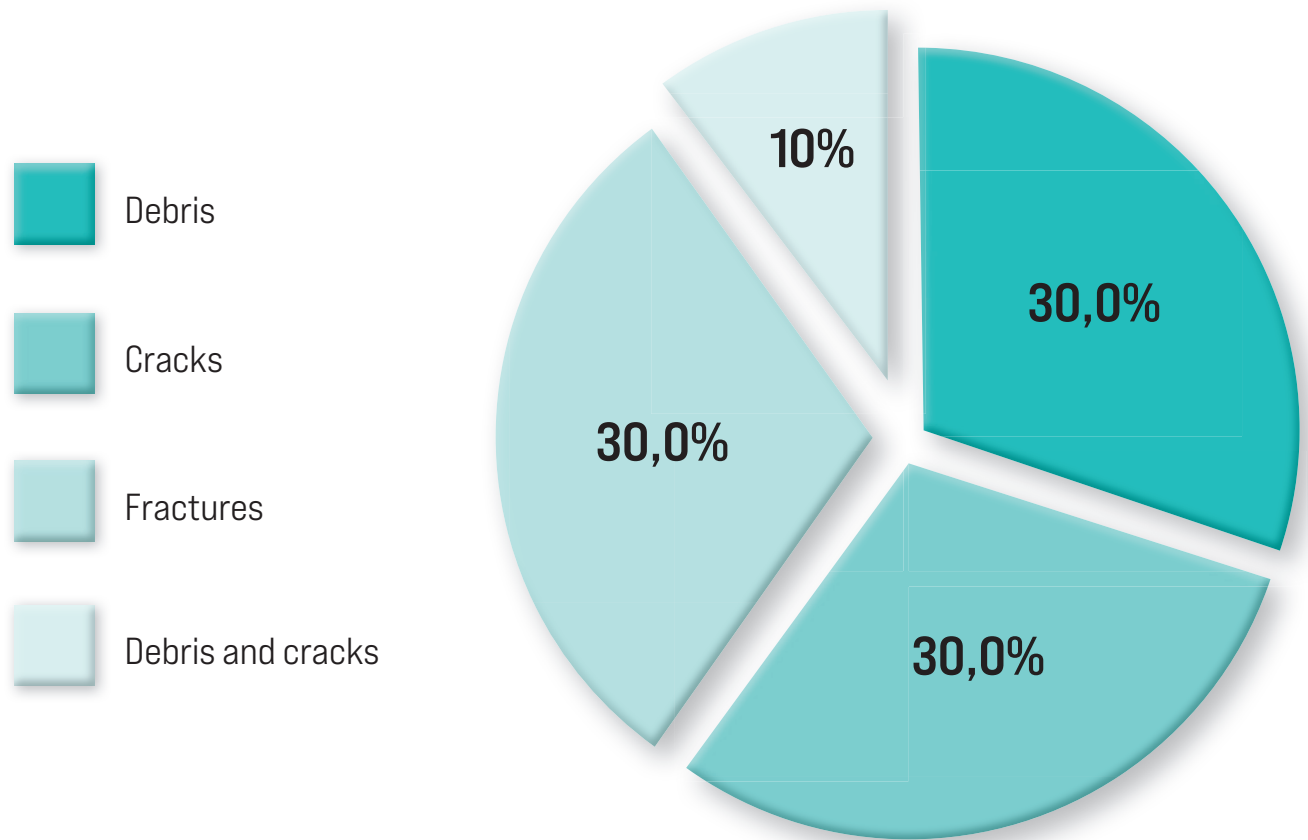
Figure 2: Frequency distribution of the qualification of the photopolymerizer tips used in the clinic of a dental school.

Also according to the data in Figure 2 (only 2 devices - 10%) presented tips with the presence of debris / cracks. According to Miyazaki et al.⁹, this type of modality can reduce the emission of light intensity by 46.2%. In this study it was found that with the replacement of the tips, the irradiance increased by 43.22%, leaving the devices in ideal conditions for use. According to Balbi et al⁷, the evaluation of the light curing tips revealed that 13.33% had a fracture and 86.66%, debris, differing considerably from the results found in this study. According to Figure 2, 30% of the tips were fractured and 30% were with debris. The difference in results can be justified by the biosafety protocol implemented by the Dentistry clinic, in which plastic film that is smooth, transparent and well adhered to the light tips of the photopolymerizing devices is used. However, when this measure was adopted, the devices had been in use for at least 2 years.

have found that some brands of curing light may not be able to maintain the same emission power after 100 cycles, others not even after 50 cycles. Therefore, one of the ways to maximize restorative procedures in the clinic of the Faculty of Dentistry was the implementation of a periodic maintenance program for the photopolymerizing devices, carrying out monthly measurements of the intensity of the light emitted, with the aid of radiometers and, based on the needs observed, the tips, batteries and even the devices will be replaced. The maintenance of light curing devices is as important as any other care to avoid failures in aesthetic restoration with composite resin.²⁰
