Assessment of bone/implant interface through SEM

Images taken with the Scanning Electron Microscope (SEM) of the interface between bone and Nanotite™ implant (Biomet 3i®), with twenty-one days of osseointegration.

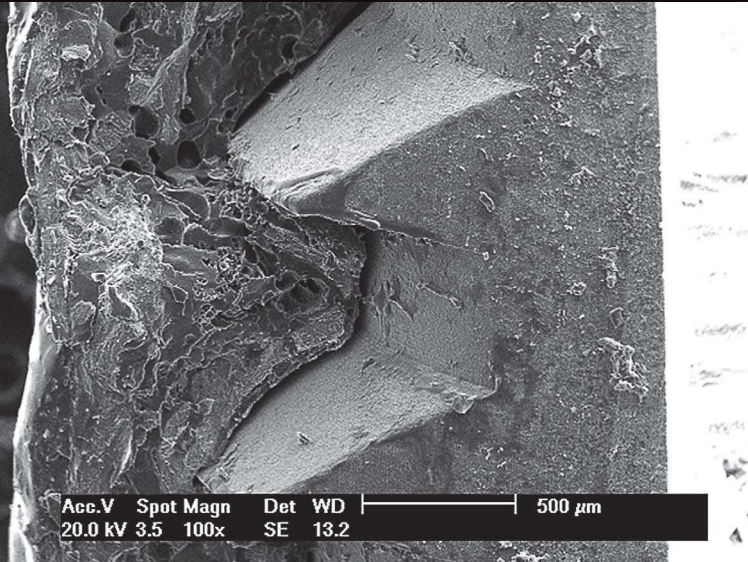
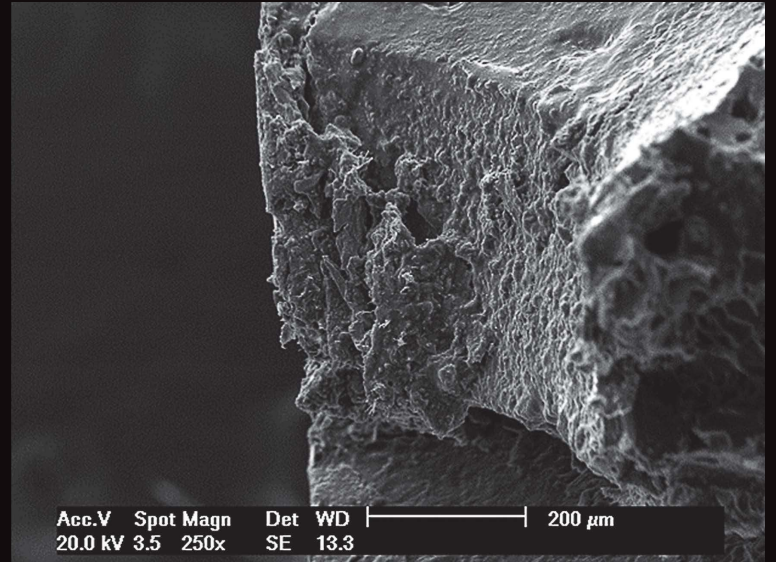
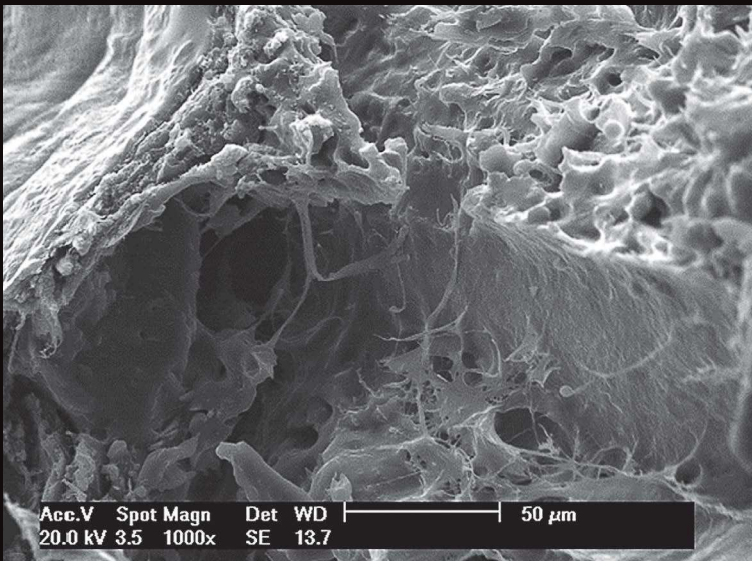
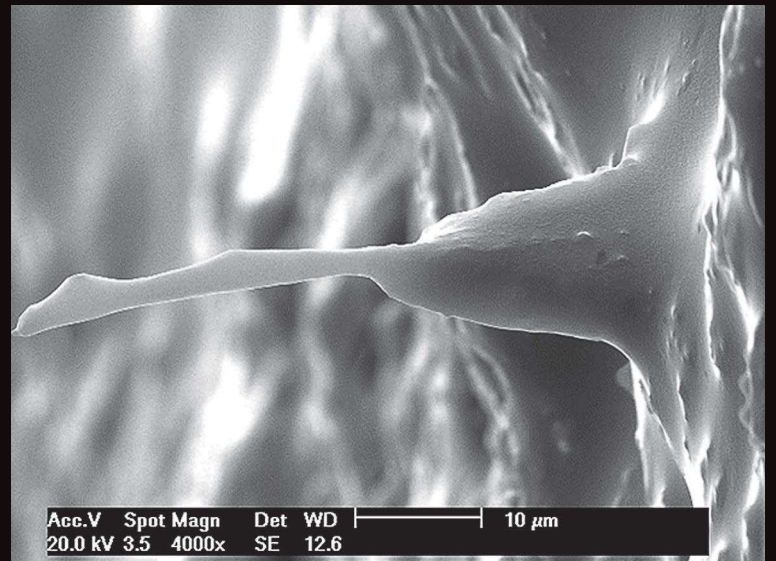
It is observed the intimate contact of bone with titanium nano-textured surface, as well as calcification of the collagen matrix and bone extensions created toward the surface of the implant.
