# Accidental implant displacement into maxillary sinus

**How to cite this article:** Queiroz CS, Silveira BBB, Castro CHS, Oliveira Junior JATB, Araújo MAV, Matos D, Miranda DAO. Accidental implant displacement into maxillary sinus. *Dental Press Implantol.* 2012 July-Sept;6(3):91-6.

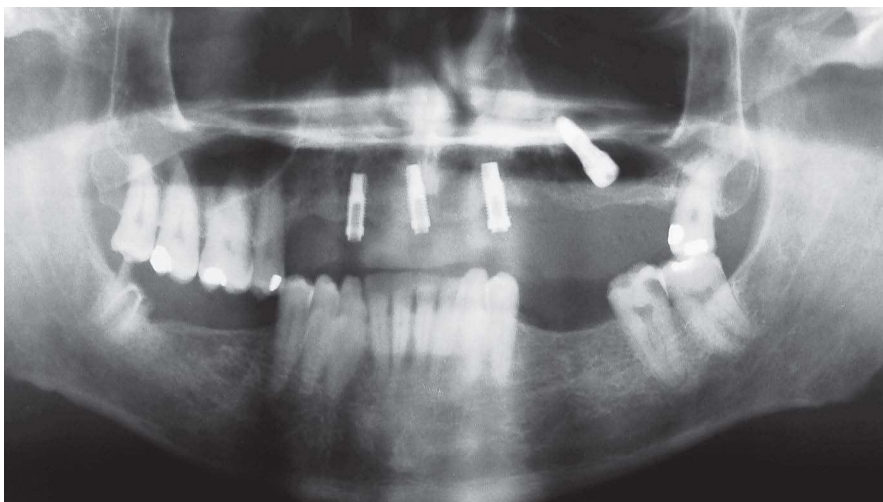
**Figure 1** - Preoperative panoramic radiograph showing metal instrument in the region of the left maxillary sinus.

Palpation of the maxillary sinus region showed no clinical signs of inflammation, despite the patient's report. Panoramic radiography and routine laboratory tests were then ordered. Panoramic radiography showed an image suggestive of a radiopaque metal instrument in the posterior aspect of the left maxillary sinus, compatible with an implant (Fig 1). Analysis of the case records led to the conclusion that it would be impossible to surgically remove the object by drilling, which had been tried previously.

Foreign bodies can move within the sinus cavity. Therefore, imaging studies should preferably be conducted prior to surgery.<sup>2</sup> In the present case, panoramic radiography was used as a complementary imaging exam to pinpoint the exact location of the implant displaced into the sinus.

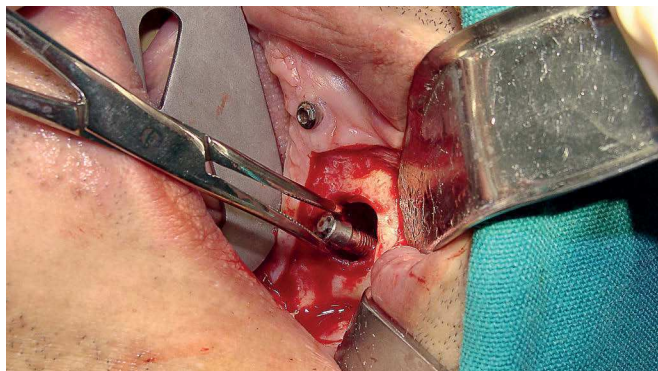
**Figure 2** - Removal of implant from inside the maxillary sinus with the aid of a hemostat.

bottom of the sulcus. With the aid of retractors, the flap was raised along with the periosteum, exposing the lateroanterior wall of the maxillary sinus and the base of the zygomatic bone. An elliptical window was prepared with carbide bur n° 8 (Komet®, Besigheim, Germany) and a straight piece under copious irrigation with saline. The implant, located at the rear of the maxillary sinus, was removed through the opening with the aid of a hemostat (Figs 2 and 3). The site was then copiously irrigated with 0.9% saline and sutured with nylon 4.0 with the key purpose of repairing the mucous membrane.

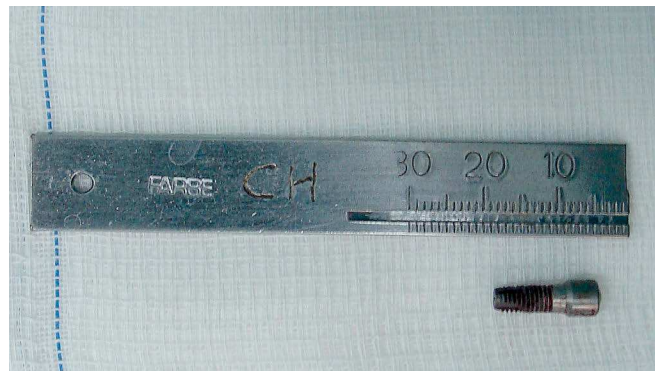
**Figure 3** - Implant removed.

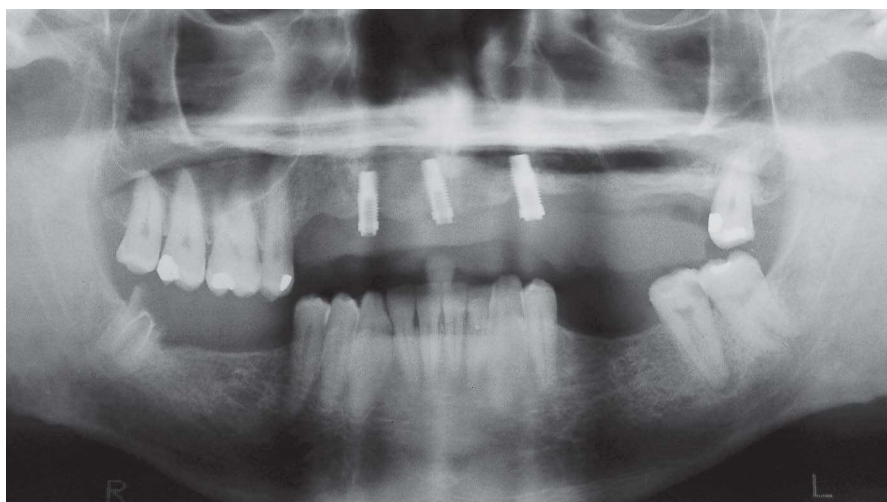
**Figure 4** - Postoperative radiograph after 6 months showing implants placed in the anterior maxilla with no trace of the implant which had accidentally been displaced into the maxillary sinus.

Suture removal was performed after seven days, and no major complications were noted during this period. Six months after implant removal a new panoramic radiograph was taken, and the displaced implant was no longer seen in the maxillary sinus. Furthermore, the other implants were found to be in their proper position as planned (Fig 4). Currently, the patient is scheduled by his implant dentist to undergo maxillary sinus grafting and placement of a new implant in the region, aimed at subsequent prosthetic rehabilitation.
