# Accidental swallowing of a Protaper® file during root canal treatment

**How to cite this article:** Kataoka SHH, Moreira F, Boutteville L, Caldeira CL, Pessoa OF. Accidental swallowing of a Protaper® file during root canal treatment. *Dental Press Endod.* 2011 July-Sept;1(2):89-93.

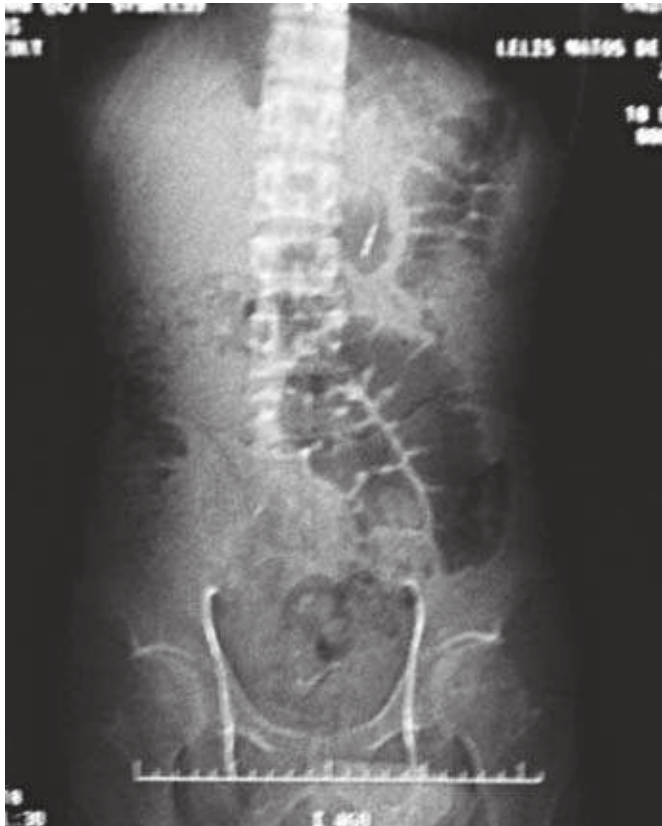
**Figure 1.** Stomach computer tomography.

Male patient, 28 years-old, submitted to endodontic treatment of left mandibular first molar, without the use of absolute isolation, swallowed a Protaper® S1 file, 25 mm in length. After referral to the Emergency Room, chest X-rays were performed 24 hours after the accident and medical recommendation was implemented. 12 hours after the radiographies, a computed tomography (CT) was performed, suggesting that the instrument was found in his stomach (Fig 1). By the gastroenterologist advice, the patient underwent an upper gastrointestinal videoendoscopy in order to remove the instrument by laparoscopy, but it was unsuccessful. The patient was then referred to the endoscopist, who warned about the fact of a possible overlap of the bowel, creating a false impression of a foreign body in the stomach. It was then requested an abdominal radiography, which was performed 2 hours after the laparoscopic surgery, noting that the instrument was located close to the angle of the cervix or spleen (Fig 2). The medical advice

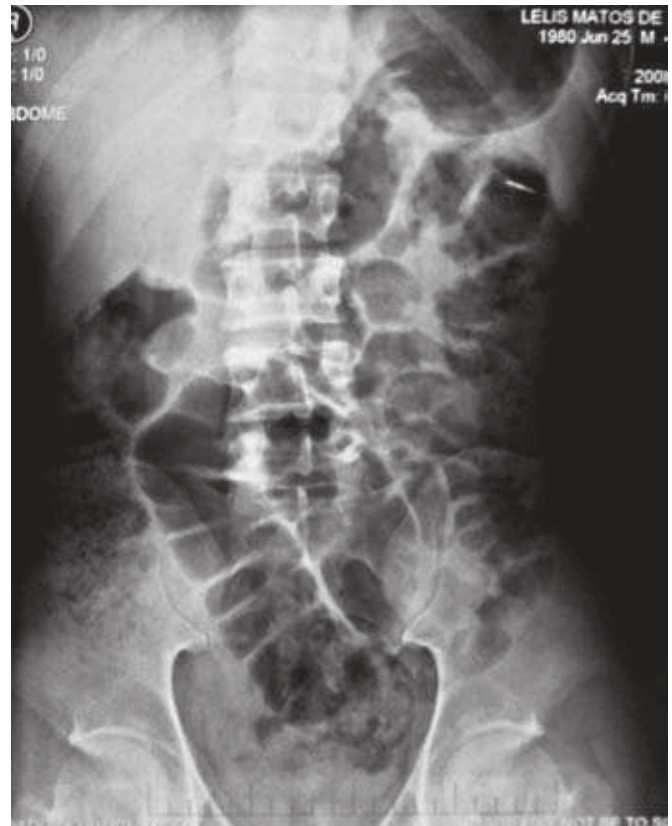
**Figure 2.** Abdominal X-ray showing the S1 file located close to the angle of the spleen.

was to perform radiographic monitoring every 12 hours, without food restrictions, discarding the need for hospitalization. After 15 hours the instrument was in the large intestine descending colon (Fig 3). Radiographs of the 2 subsequent days showed that the instrument was located in the pubis and rectum, respectively (Figs 4 and 5). The foreign body was expelled naturally by the patient 72 hours after the last radiography, and he did not want to do other radiography to confirm the file elimination.

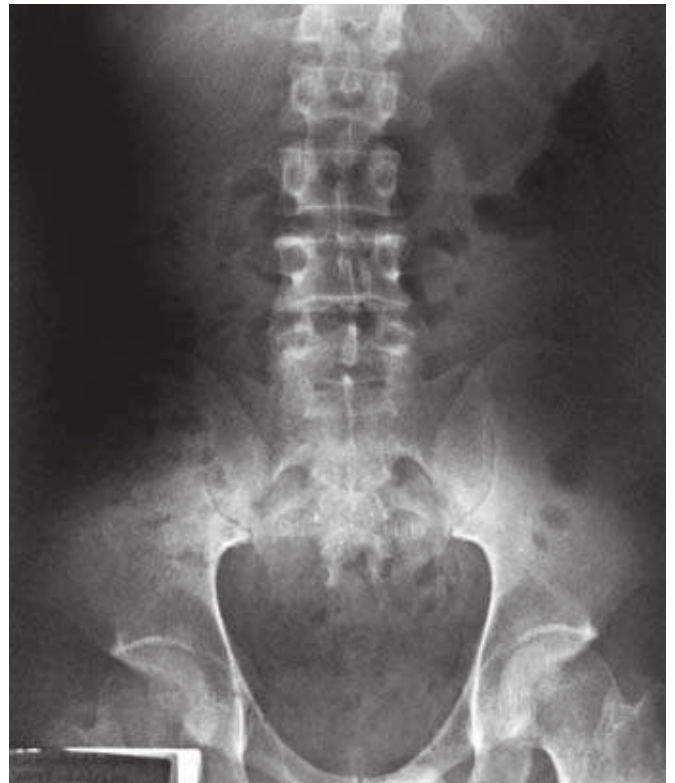
**Figure 3.** Abdominal X-ray in the large intestine descending colon.

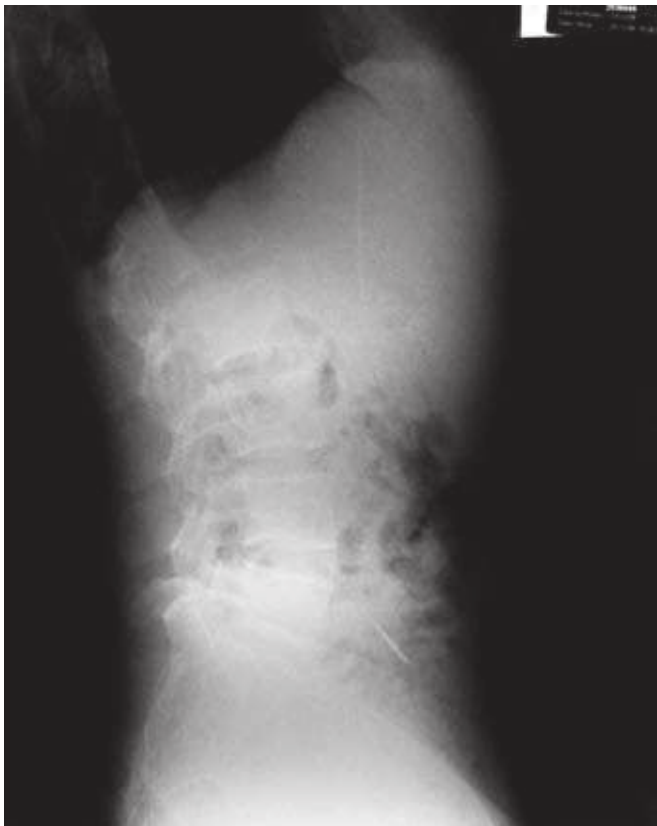
**Figure 4.** Abdominal X-ray, S1 file in the pubis (lateral view).

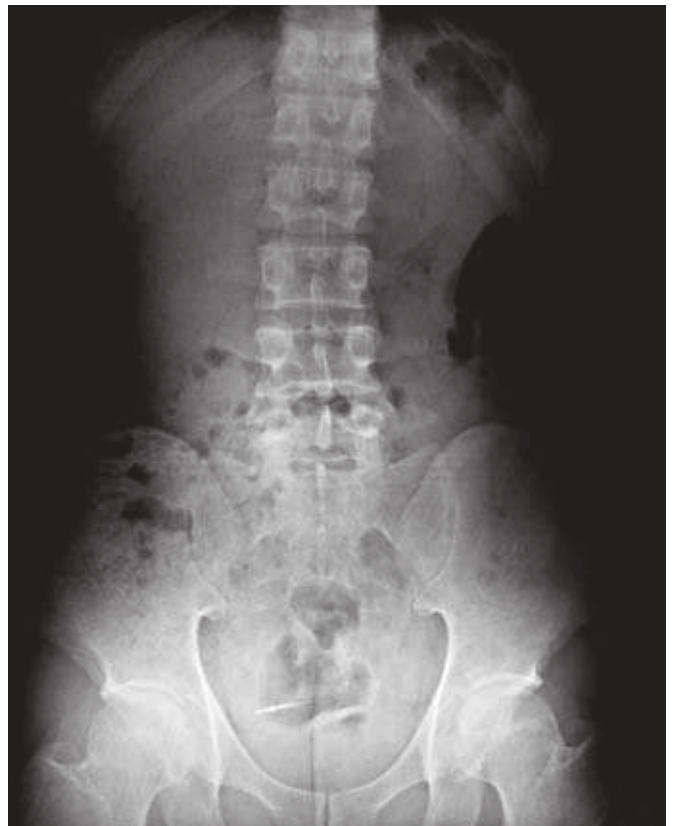
**Figure 5.** Abdominal X-ray, S1 file in the pubis.

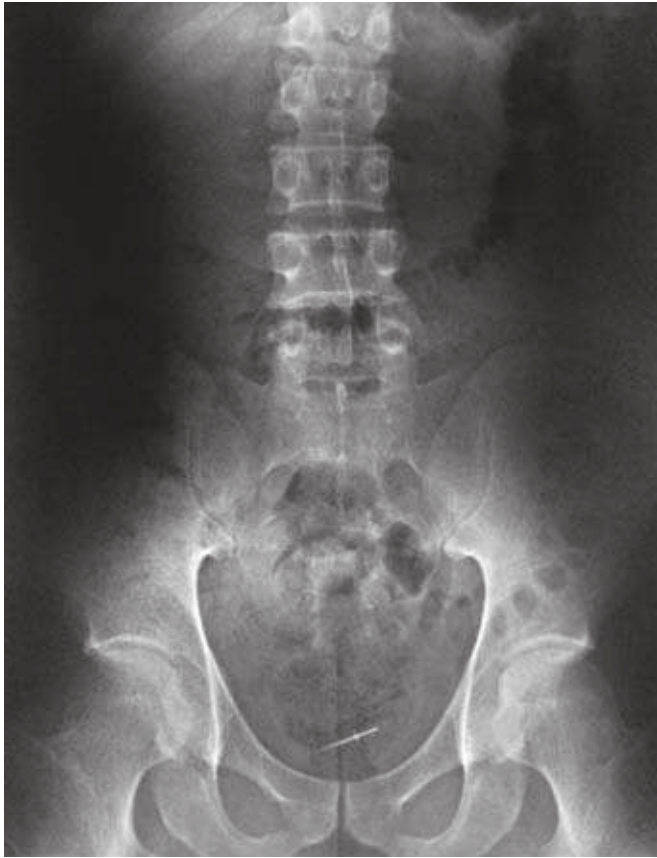
**Figure 6.** Abdominal X-ray, S1 file in the rectum.
