The objective of this study is to present a case report of restoration of an weak endodontic treated tooth fractured due to occlusal overload. The clinical sequence includes tooth fragment stabilization and reattachment and insertion of glass fiber post, periodontal assessment and occlusal adjustment with 6 months follow up.

Case report

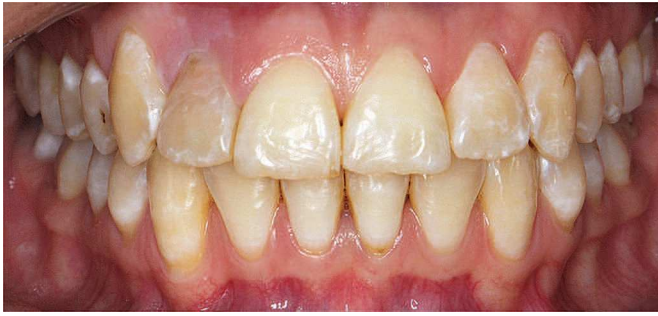
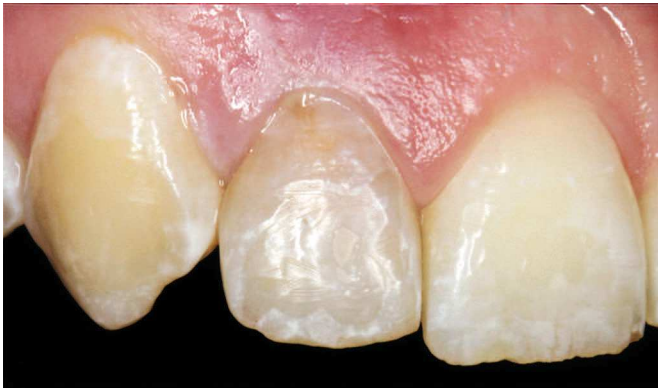
been submitted to endodontic treatment for more than 5 years ago, before orthodontic treatment. Clinically, it was observed that the fragment was represented by entire dental crown, which remained in place because of subgingival periodontal ligament attachment. Figure 1 shows the purplish appearance of supporting periodontal tissues as a result of an inflammatory episode after fracture; however, the fragment was intact and looking good at vestibular side. Patient teeth showed demineralized white spots from remineralized enamel caries after orthodontic treatment. Radiographic analysis (Fig 2) revealed fracture near the bone, requiring correction of biological distances.

Figure 1. Initial image of darkened tooth #12 and inflammation of supporting tissues due to subgingival fracture.

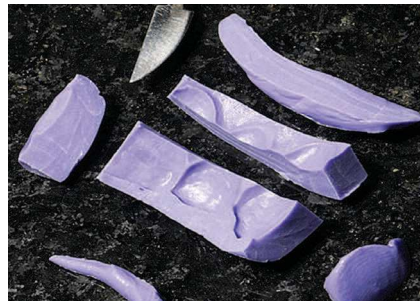
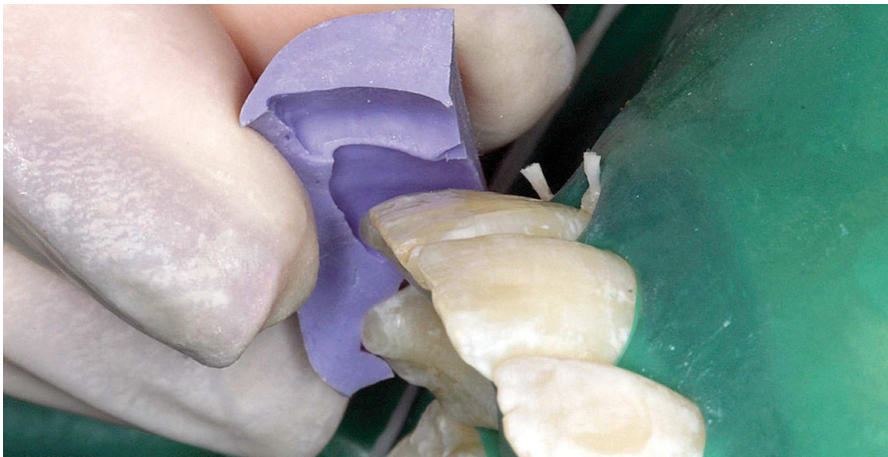
Figure 3. Direct impression of properly re-positioned teeth for producing the polyvinylsiloxane matrix. The matrix was cut with a scalpel blade maintaining the incisal portion to be used for fragment fixation.

In order to allow periodontal surgery procedures to expose the fracture line, tooth #12 should be fixed at its original position, adopting the following technique. After perfect adaptation of the fragment, a polyvinylsiloxane matrix (Futura AD, Nova DFL, RJ, Brazil) was manufactured (Fig 3) to hold the tooth in position during procedures for adhesive anchorage.

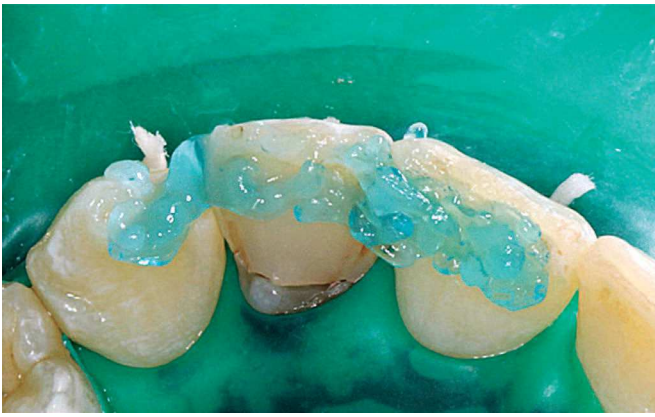
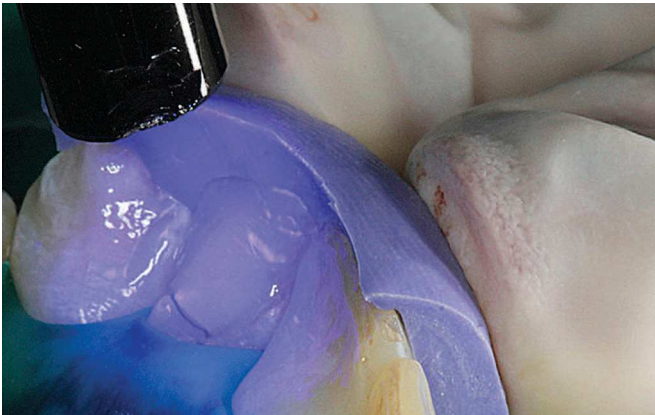
Figure 4. Adhesive technique for fixation of the fragment on adjacent teeth. For the fixation, the silicon matrix must be kept in place during the photopolymerization of the bonding agent and composite resin.

Teeth #11, #12 and #13 were etched with 37% phosphoric acid (Alpha Etch, Nova DFL) for 15s and a dentine bonding agent (Adper Single Bond 2, 3M-ESPE, USA) was applied in two layers with gentle air in their palatal surfaces. Before photopolymerization, the matrix was positioned and then light exposition performed for 20s in each tooth. A composite resin layer (Natural Look, color A1E, Nova DFL) with an average thickness of 2 mm was used and light cured for 40 seconds per tooth (Fig 4).

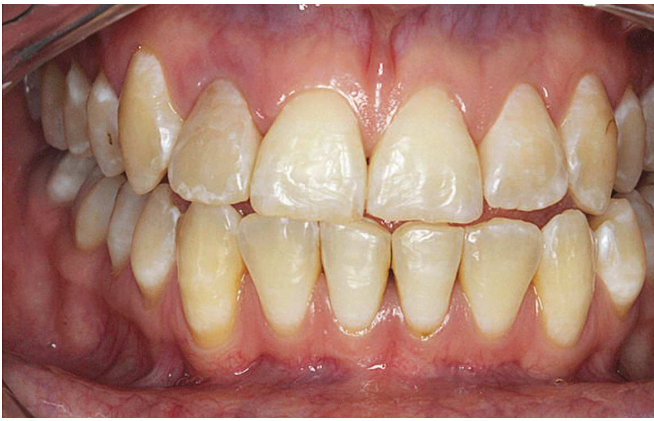
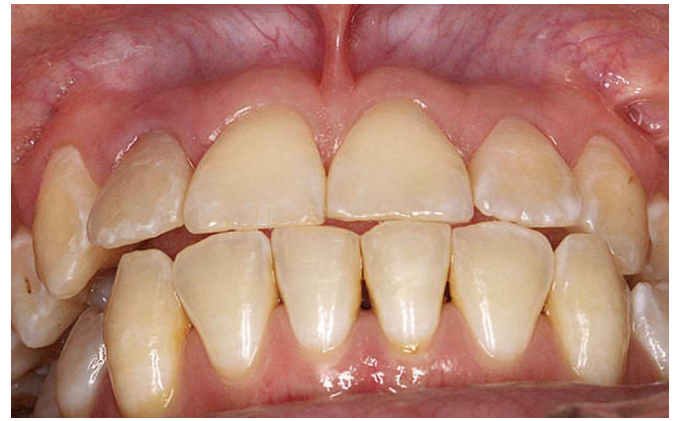
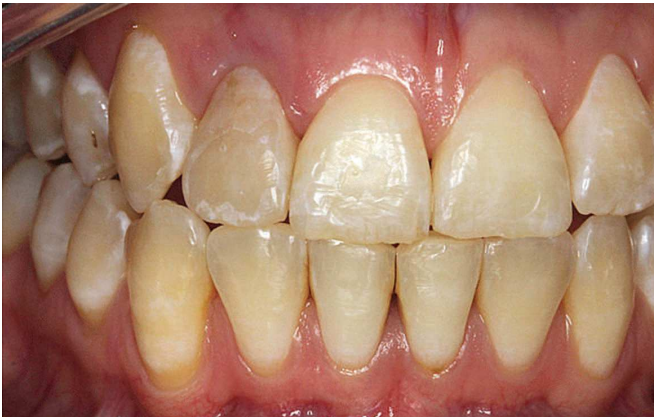
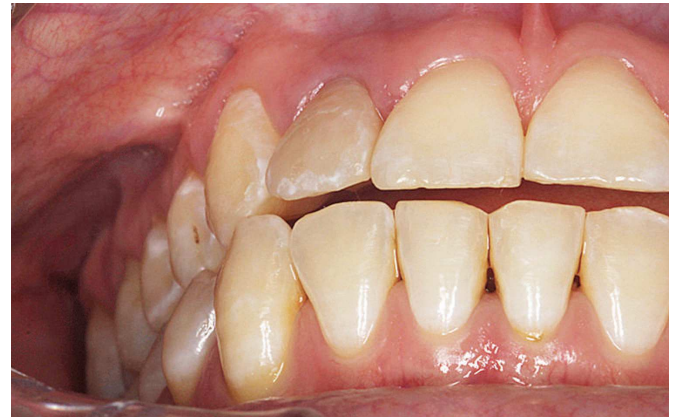
Figure 7. Excursive mandibular movements with anterior guides protecting tooth #12. Upper pictures shows protrusion with absence of contacts in #12, which is also observed in the lower pictures with right laterality.

In Figure 6 it is possible to see the immediate restoration with a lighter appearance of gingival tissue and restored tooth. The patient was referred for periodontal evaluation, and during surgery it was noticed the perfect adaptation of the reattached fragment. Figure 7 shows excursive mandibular movements of protrusion (upper images) and right laterality (lower images), showing the correct occlusal adjustment, relieving any contact on the restored tooth and maintaining balanced contacts. Figure 8 shows 6 months follow-up, with gingival health and maintenance of the initial result.

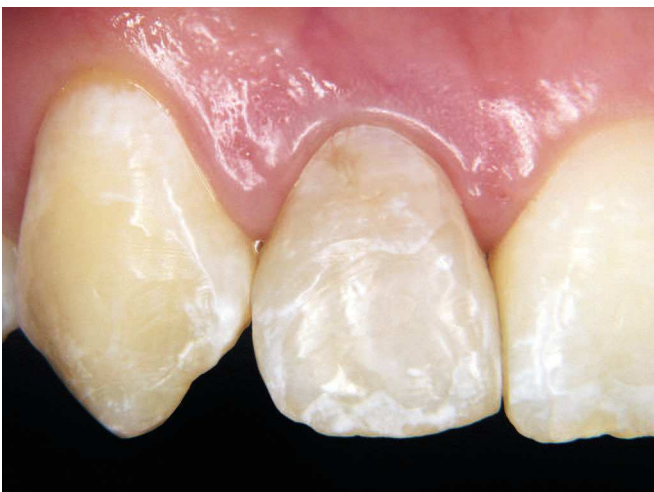
Figure 8. Image of 6 months follow-up showing the quality of supporting tissues and tooth color.
