Endodontic intervention in mandibular premolar with complex anatomy associated to cracked root diagnosis: Case report

How to cite: Ruas ESP, Silva RV, Pereira RP, Nunes E. Endodontic intervention in mandibular premolar with complex anatomy associated to cracked root diagnosis: Case report. *Dental Press Endod.* 2017 Jan-Apr;7(1):78-84. DOI: <http://dx.doi.org/10.14436/2358-2545.7.1.078-084.oar>

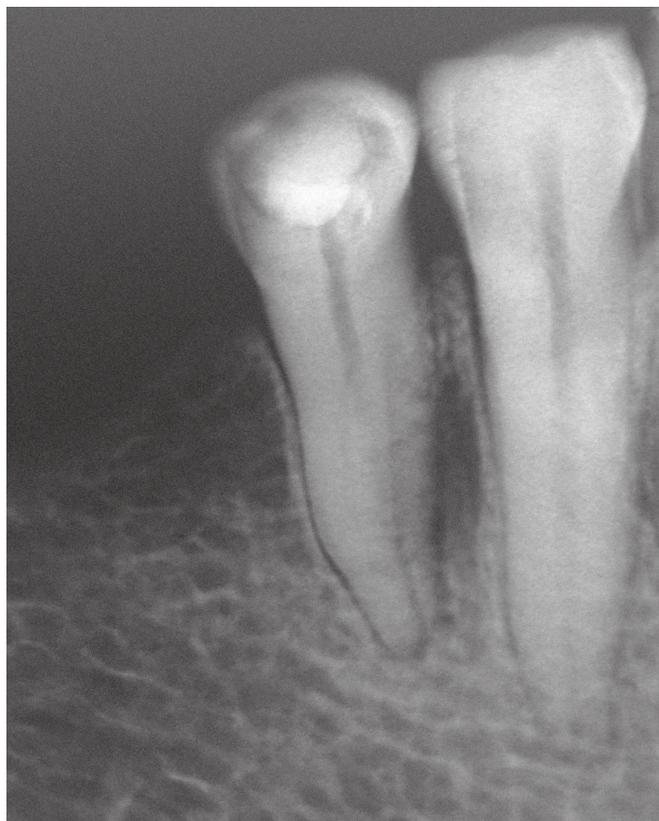
Figure 1. Study radiograph.

Female Afro-Caucasian patient was referred to a specialized dental office for endodontic assessment of her mandibular first premolar on the right side (#44). The main complaints were painful symptoms a few days before, and sensitivity to palpation. Medical history was not relevant. Clinical examination revealed the tooth provided support for a removable partial prosthesis and had a restoration in class I composite resin. It exhibited physiological dental mobility, probing depth of 2mm and absence of bleeding at all sites. She also presented discreet swelling in the internal wall of the vestibule and active intraoral fistula. All thermal and electric pulp sensitivity tests were performed, with negative responses. Radiographic examination revealed complex anatomy with narrow root canals, two apparently fused roots, and an image suggestive of rare diffuse lateral osteitis, mesial to the middle third of the root (Fig 1). Pulp necrosis and periapical diagnosis of chronic periapical abscess of tooth #44 was established. Endodontic therapy was then instituted as treatment modality.

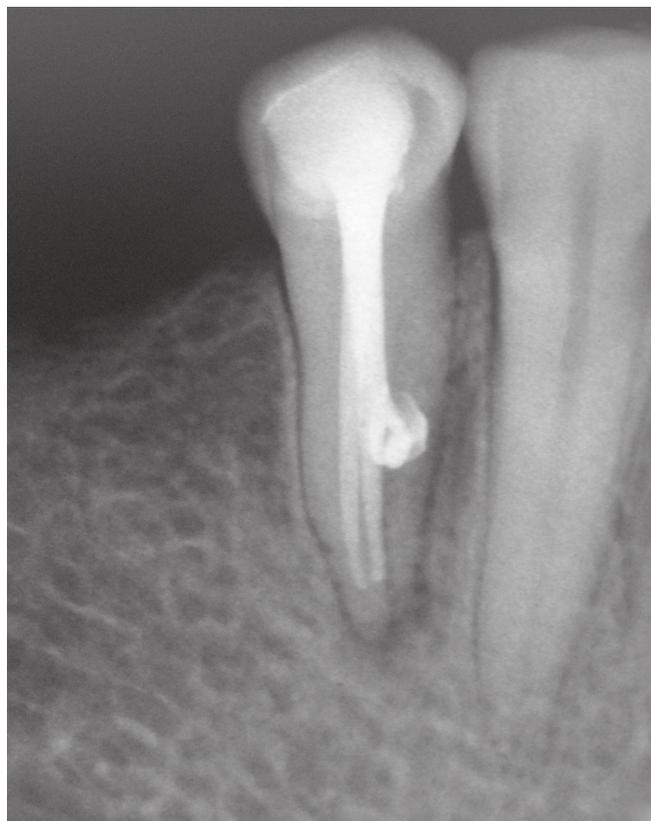
In the second session, 30 days later, the patient was asymptomatic, with healing fistula. Root canal filling was performed by means of the thermoplastic vertical hydraulic compression technique of the accessory point (Fig 2), with F3 cones of the Protaper system combined with AH Plus sealer (Dentsply, De Trey GmbH, Germany), in addition to crown sealing with coltosol (Vigodent, Rio de Janeiro, RJ, Brazil)

Figure 2. Root canal system filling radiograph.

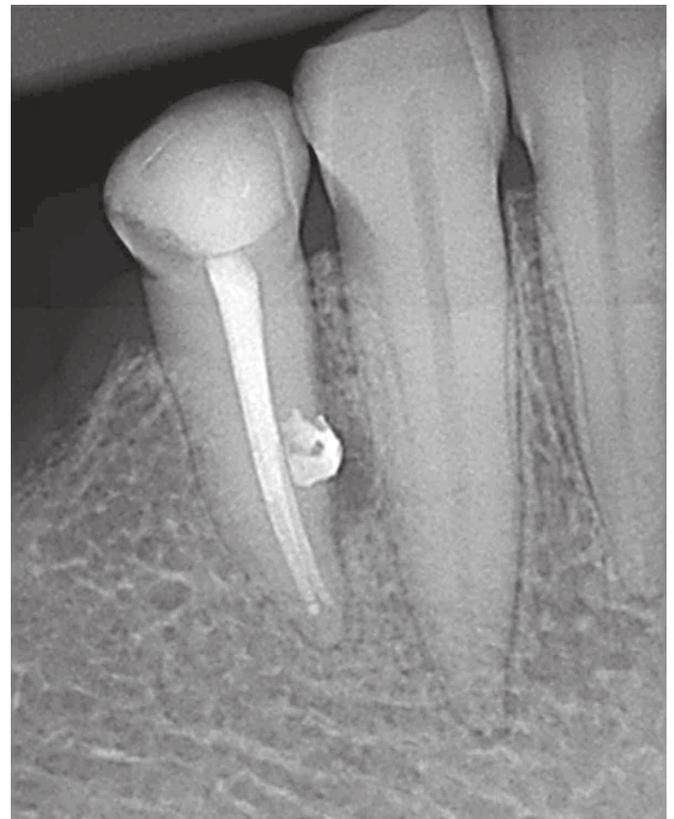
the radiolucent area, compatible with rare diffuse lateral osteitis, similarly to that diagnosed in the beginning of the proposed therapy (Fig 4). CBCT scans were obtained with the objective of investigating the potential for cracked root and/or root fracture that explained why periapical pathology had reappeared. However, the images did not contribute to diagnosis (Fig 5).

Figure 4. Follow-up two years and six months later.

Long-term clinical success can be influenced by several factors. In the case reported herein, after two and a half years of endodontic intervention, a new control appointment was scheduled due to complaint of painful symptoms. Clinical and radiographic reassessment demonstrated recurrence of the periapical lesion, exactly in the same place, and determined a diagnosis suggestive of cracked root. In addition to susceptibility of fractures in premolars due to their anatomy, clinical signs fulfill several prerequisites that may be associated with cracked root. Painful symptoms, periodontal pocket and fistula are present in most cases. Inspection with an exploratory probe aiming to feel the line of fracture contributes to diagnosis. Such conditions are sometimes linked to other factors, such as cracks, thus making treatment prognosis difficult.^{12,21-23} In the present case report, it was not possible to perform this procedure.
