Management of complications associated with single implants in esthetic zones: a case report

Abstract: Problems related to complications associated with dental implants in esthetic zones have become increasingly common in the clinical practice. Among those problems, the most common mistakes include: malposition of the implant, inadequate restoration contour, and lack of adequate treatment planning. The description of the case presented in this article shows a clinical sequence, from surgery to prosthetic procedures, employed to retreat two implants in the anterior maxilla, both of which had been planned and executed incorrectly, causing esthetic and functional discomfort to the patient. **Keywords:** Dental implants. Esthetic zone. Failures. Complications. Single implant.

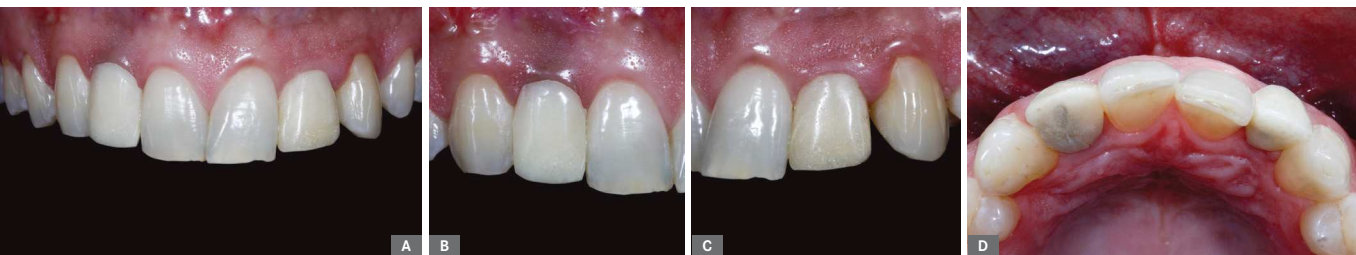
Figure 2: Patient was unsatisfied about the esthetics of the provisional restorations, as well as the grayish color of the gingival margin around tooth #7 (A, B). It is also possible to see the difference between the mesiodistal distances of teeth #7 and 10 (C, D).

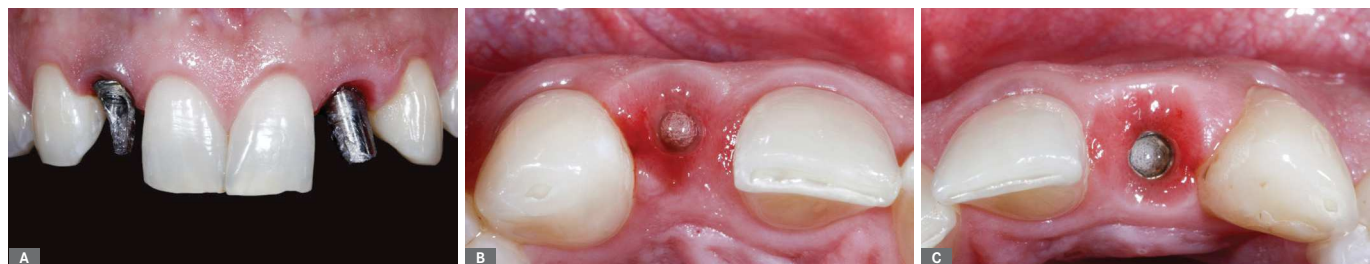
Figure 4: Temporary abutments and HE prosthetic connection of implants (A) did not favor peri-implant tissue health (B, C).

Provisional cemented crowns and abutments were removed (Fig 4) and a counter-torque ratchet (Retrieval Tool, Nobel Biocare™,

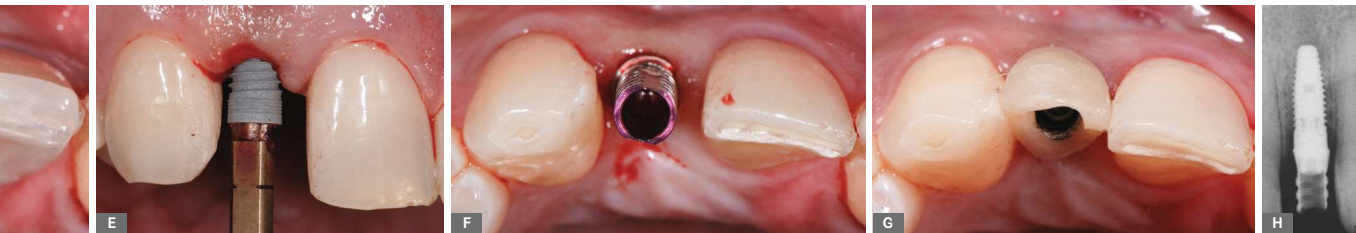
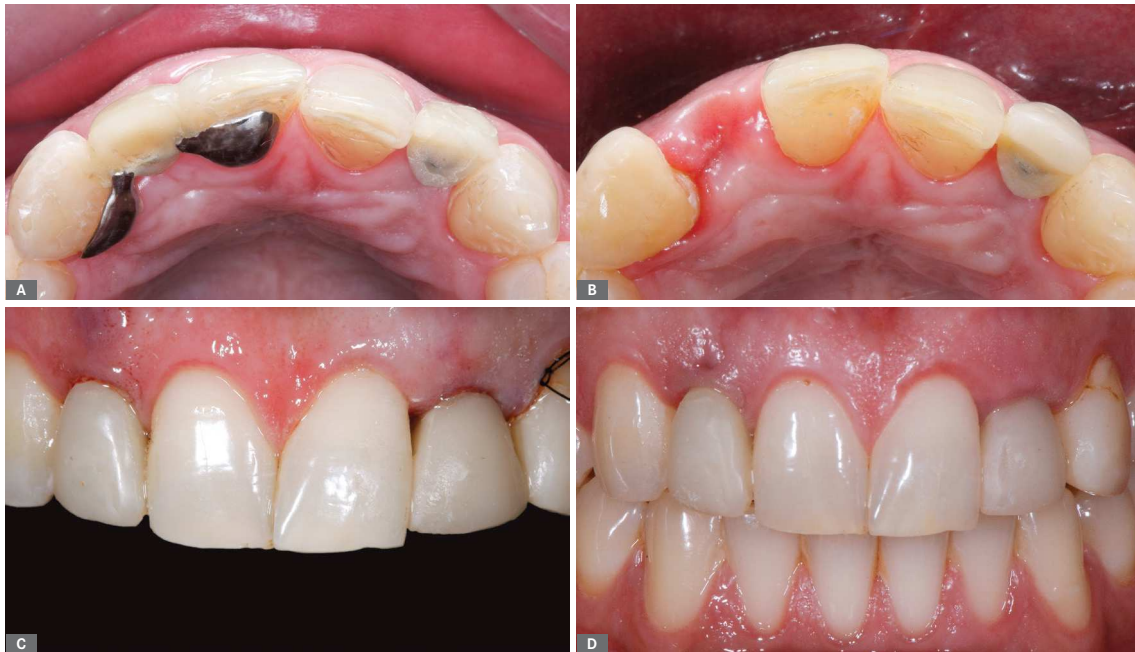
Figure 10: After a 90-day healing period, the correct gingival volume area in tooth #10 site (previously grafted) can be observed, as well as the insufficient gingival volume at tooth #7 site, which did not receive connective tissue graft at the time of implantation (A, B). Implant #10 was reentered, and temporary restoration was performed (C). 30-day post-operative aspect (D).

After a healing period of four months, conservative uncoverage surgery was performed to access the head of implant #10 (Fig 10). A punch-type flap helped to preserve the interproximal tissue, facilitating papillae regeneration. The provisional abutment was positioned on this implant. After three months, an impression of the implants was made with polyvinyl siloxane (PVS), using the impression posts of the corresponding diameter and design, in order to produce a new set of temporaries in the laboratory. In the laboratory, a working stone cast was poured with a gingival mask to reproduce the original soft tissue condition. In this phase, the dental technician reshaped the gingival resilient material to the desired shape, creating an adequate emergence profile. Two new provisional abutments were modified

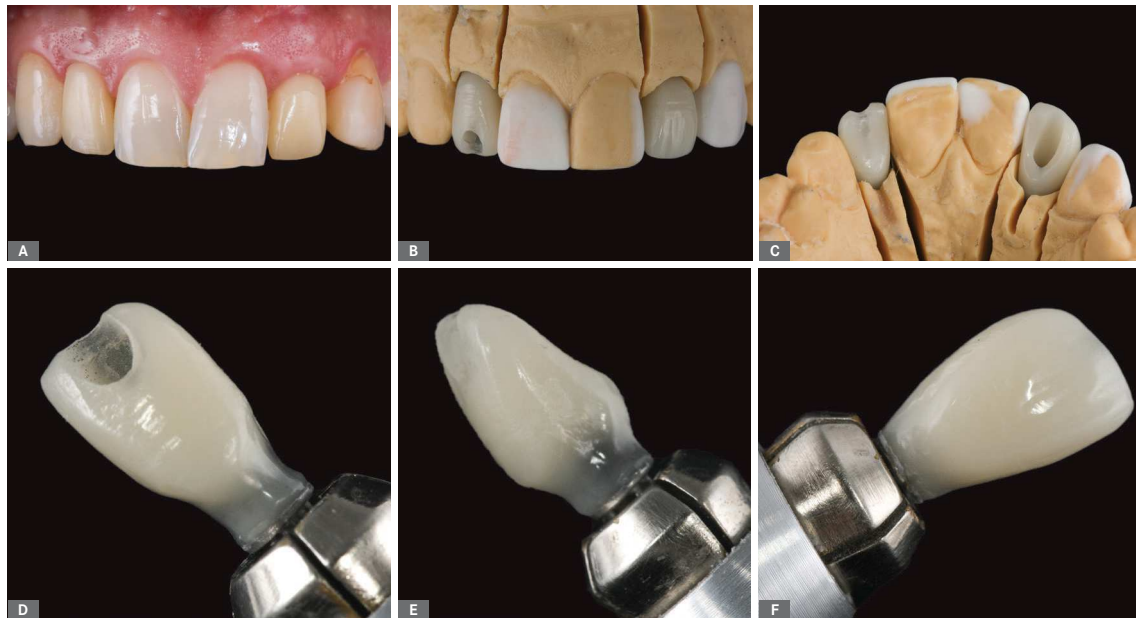
Figure 11: Screwed provisional restorations were made (A, B) and modified, so that the trans mucosal concave portion was properly polished, allowing greater soft tissue thickness at this area (C, D, E).

and adjusted in order to support the desired peri-implant tissues developed by the technician. These screwed provisional restorations were modified, so that the transmucosal concave portion could be properly polished, allowing greater soft tissue thickness at this area. They were inserted with the patient under anesthesia, and a connective tissue graft was harvested from the anterior palate and enveloped at tooth #7 buccal aspect in order to augment the thickness of the peri-implant mucosa, which was perforated at this time.

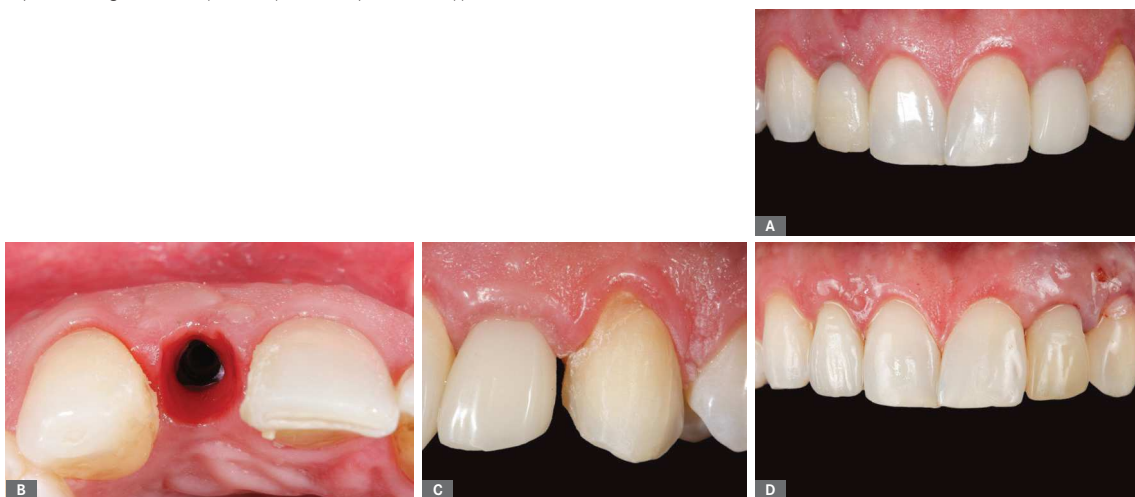
Figure 13: 60-day postoperative of tooth #7 (A, B). Another connective tissue graft was performed for root coverage of tooth #11 (C, D).

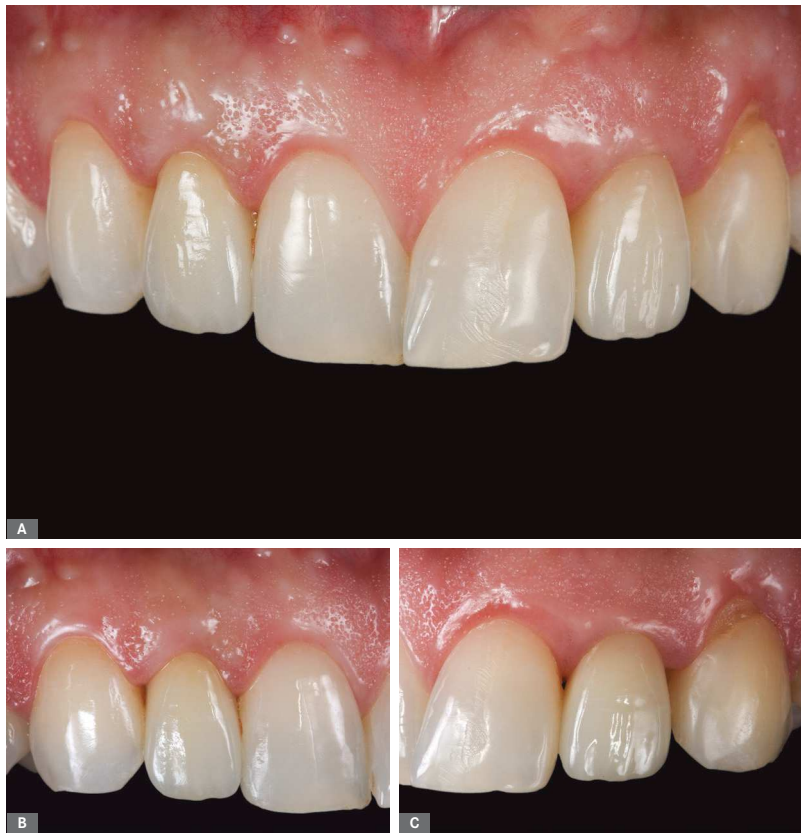
Figure 15: After teeth #7 and #10 cementation, perfect integration between implant-supported restorations and adjacent teeth can be observed. It is interesting to note that these ceramic restorations were so invisible that other minor problems became evident: polishing deficiency of composite resin restoration at distal aspect of the tooth #9 (A), and residual gingival recession of tooth #11 (C).

then immediately torqued. Final cementation was performed with resin cement (Variolink Veneer, Ivoclar Vivadent™). The final result after two weeks is shown in Figure 15. A follow-up one-year evaluation post-operatively revealed stable conditions of the soft tissue as well as shade maintenance, correct function and a perfect esthetic outcome.
