# Two-stage maxillary expansion using polypropylene barrier: case report

**How to cite:** Llantoy PCM, Humani NAT. Two-stage maxillary expansion using polypropylene barrier: case report. J Clin Dent Res. 2017 Jan-Mar;14(1):90-7.

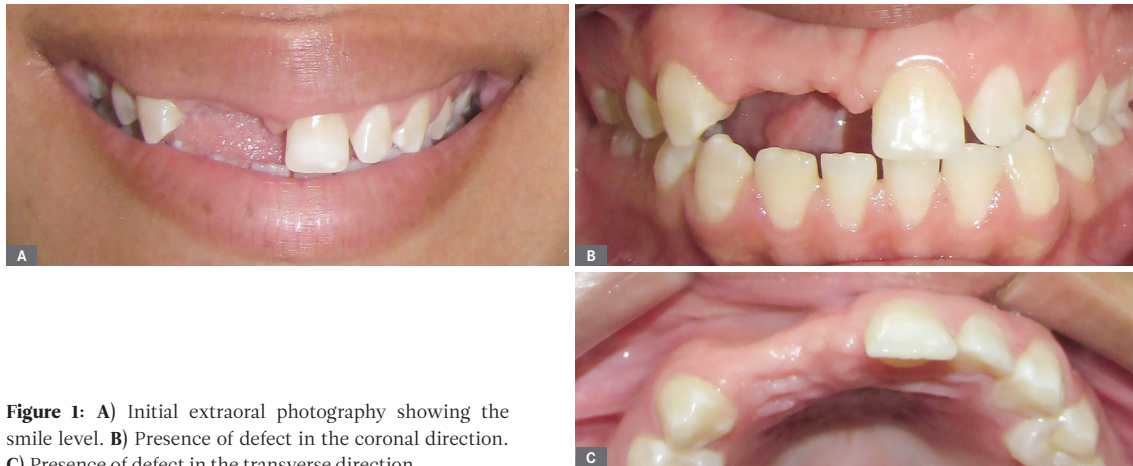
**Figure 1:** A) Initial extraoral photography showing the smile level. B) Presence of defect in the coronal direction. C) Presence of defect in the transverse direction.

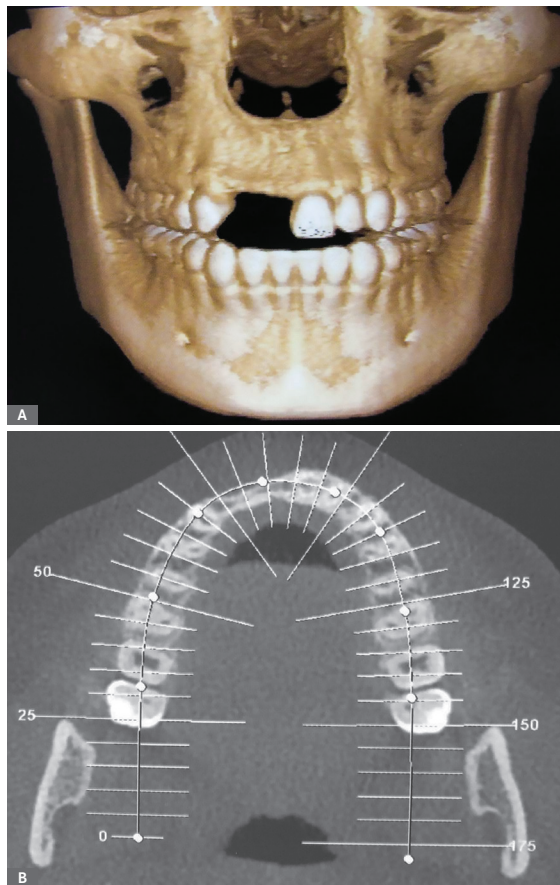
**Figure 2:** 3D Tomography showing: A) loss of elements #11 e #12, B) loss of the transverse bone structure.

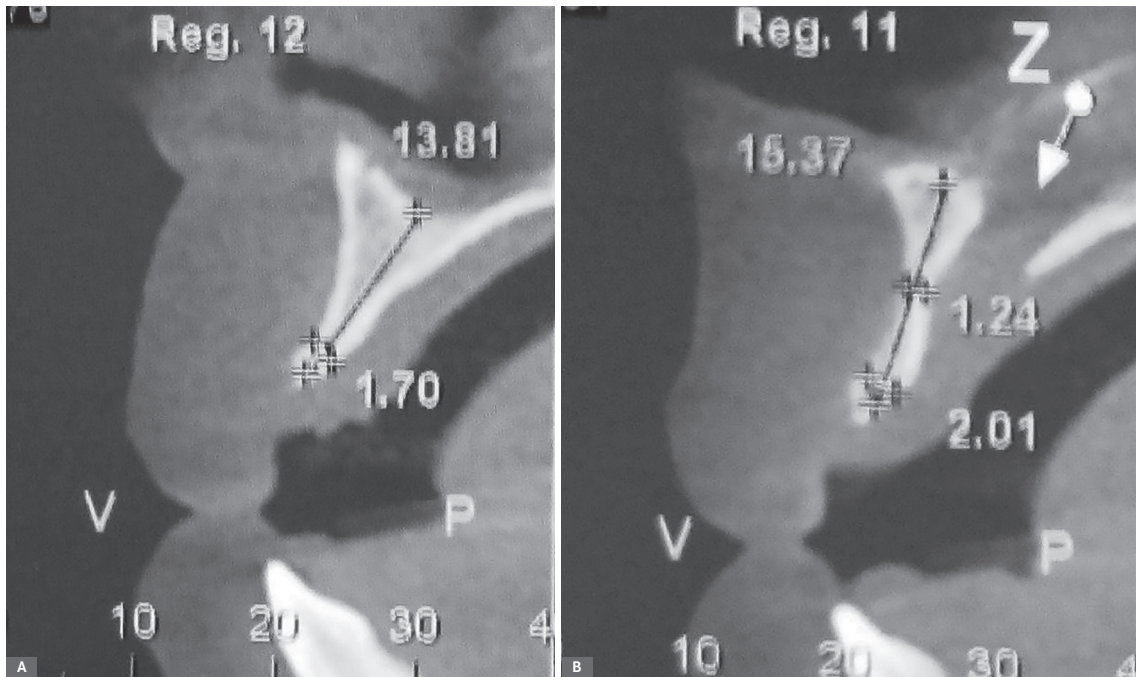
**Figure 3:** A) Dental element #12: confirmation of atrophy level in the vestibulopalatine direction, with width of 1.7mm and height of 13.81mm. B) Dental element #11: confirmation of atrophy level in the vestibulopalatine direction, with width of 2.1mm and height of 15.37mm.

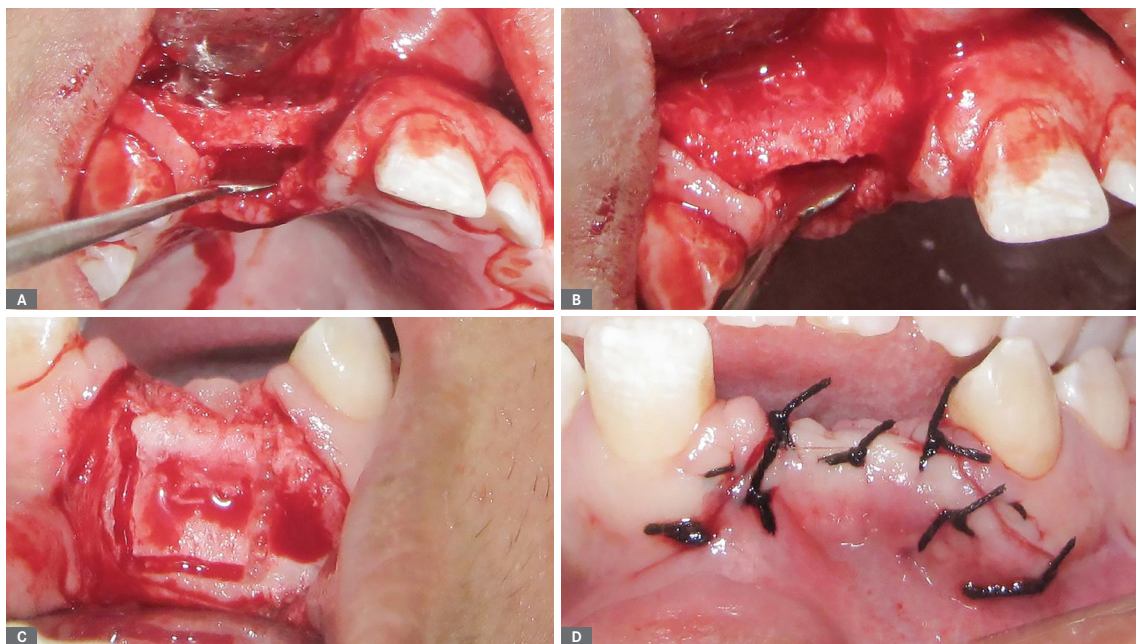
**Figure 4:** A) A broader flap was made to the bottom of the vestibule. B) Drilling with a very thin, 'U'-shaped spherical drill, until the bone marrow. C) Note the thickness of the bone in which the two-step expansion would be made. D) Replacement of the flap and suture.

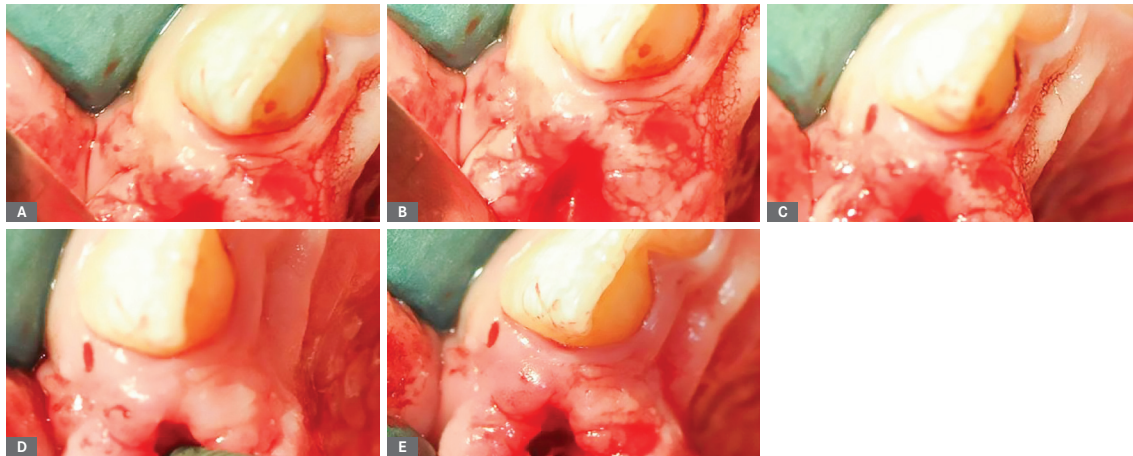
**Figure 5:** **A)** After 28 days, a flap was made in the ridge. **B)** A supracrestal perforation was performed, which can be performed with a very thin spherical drill or a scalpel blade. **C)** After drilling, the two bone plates were fractured. **D)** Immediately, two Cone Morse implants, with a diameter of 3.8mm, were installed. **E)** Implants positioned for installation of prosthetic parts in elements # 11 and # 12.

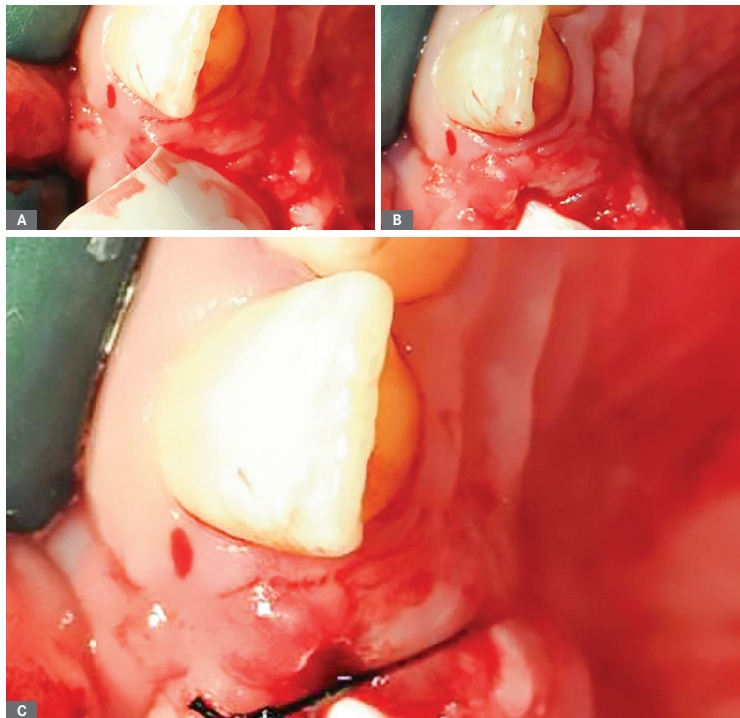
**Figure 6:** **A)** After implant placement, a polypropylene (Bone Heal®) barrier was positioned and fixed with simple sutures. **B)** This barrier was maintained (exposed) for 15 days in the mouth. **C)** The suture was performed without tension.

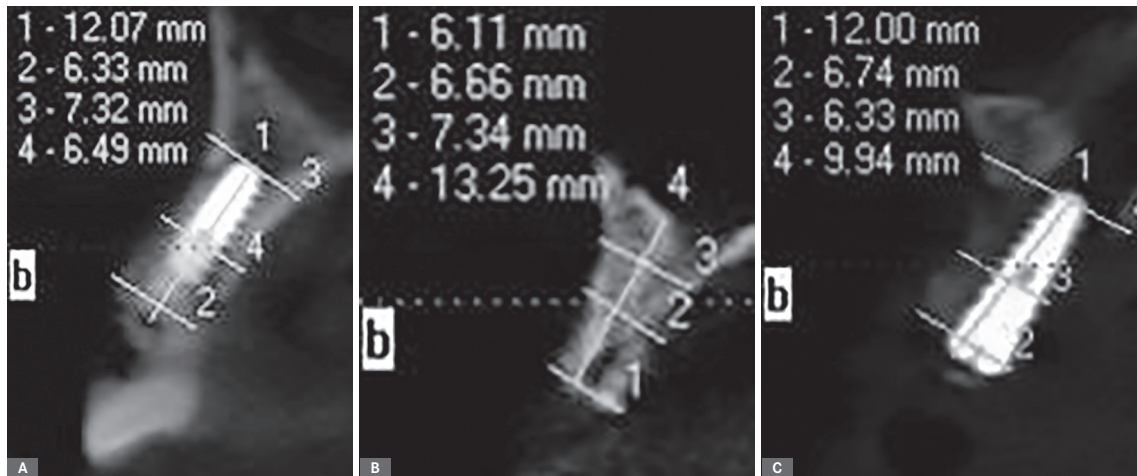
**Figure 7:** Immediately, a tomography was taken to evaluate the thickness obtained with surgery (A), in which the thickness gain (B) and the expansion that the fracture line provided (C) could be verified.

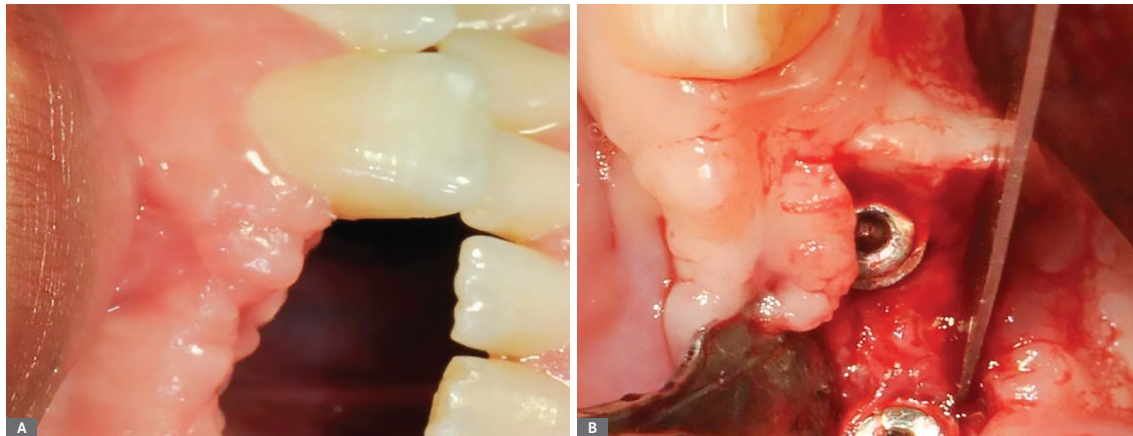
**Figure 9:** In the clinical evaluation after four months, we could observe: **A)** preservation of soft tissues; and **B)** neof ormation of the bone tissue and good gain in the thickness of the ridge.

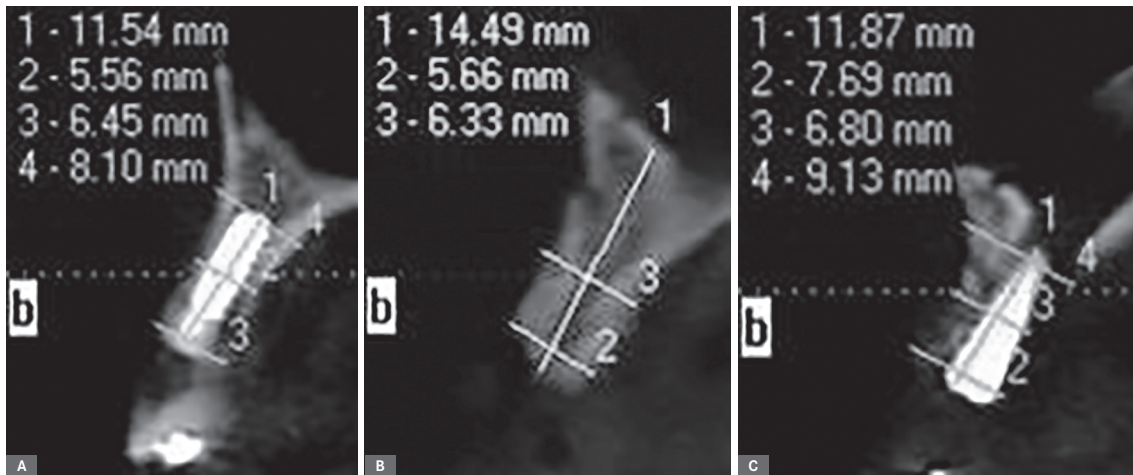
**Figure 10:** **A)** Confirmation, by tomography, of the thickness gain and bone neof ormation of 6.45 mm, at the most coronal level. **B)** Tomography after four months, confirming the thickness of 6.11 mm, at the most coronal level. **C)** Thickness of 7.69 mm, at the most coronal level.

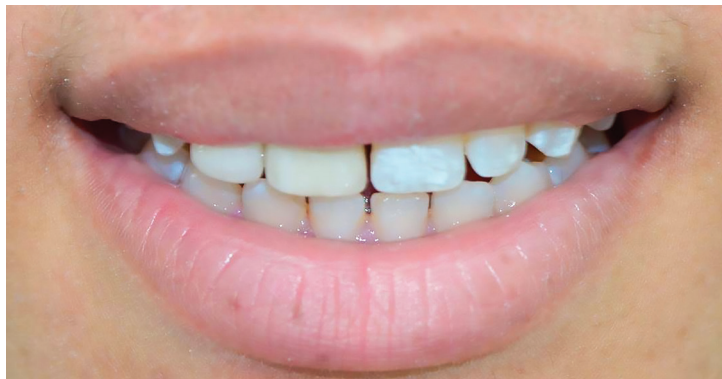
**Figure 11:** Case finished, with individual porcelain crowns in place.

After these 15 days, the patient returned, with some burst stitches and others hanging, but with the barrier still in its initial position. After removal, a granulation tissue was found, which, following the recommendations of the barrier manufacturer, should be left in this way for at least four months, when a new exposure of the implants and prosthetic rehabilitation is made. Histologically, this granulation tissue is highly vascularized. After four months, a new tomography was performed, with the intention of evaluating the effectiveness of the technique and the thickness of the newformed bone. A real bone gain could be observed, and then the implants were exposed and the unitary porcelain crown was placed on each implant.

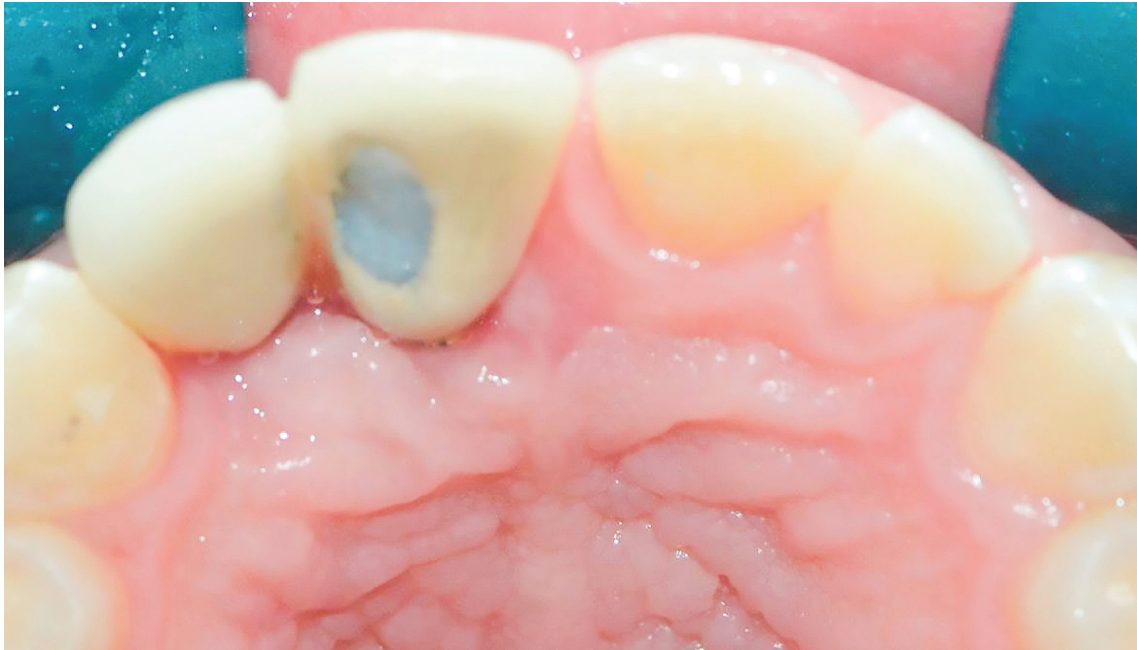
**Figure 12:** Rehabilitation of element #11, with screwed crown, and element #12, with cemented crown.
