INSTAGRAM:
NAKED AND RAW

Thiago Ottoboni¹⁻⁴

How to cite: Ottoboni T. Instagram: naked and raw. J Clin Dent Res. 2020 Jan-Apr;17(1):180-9.

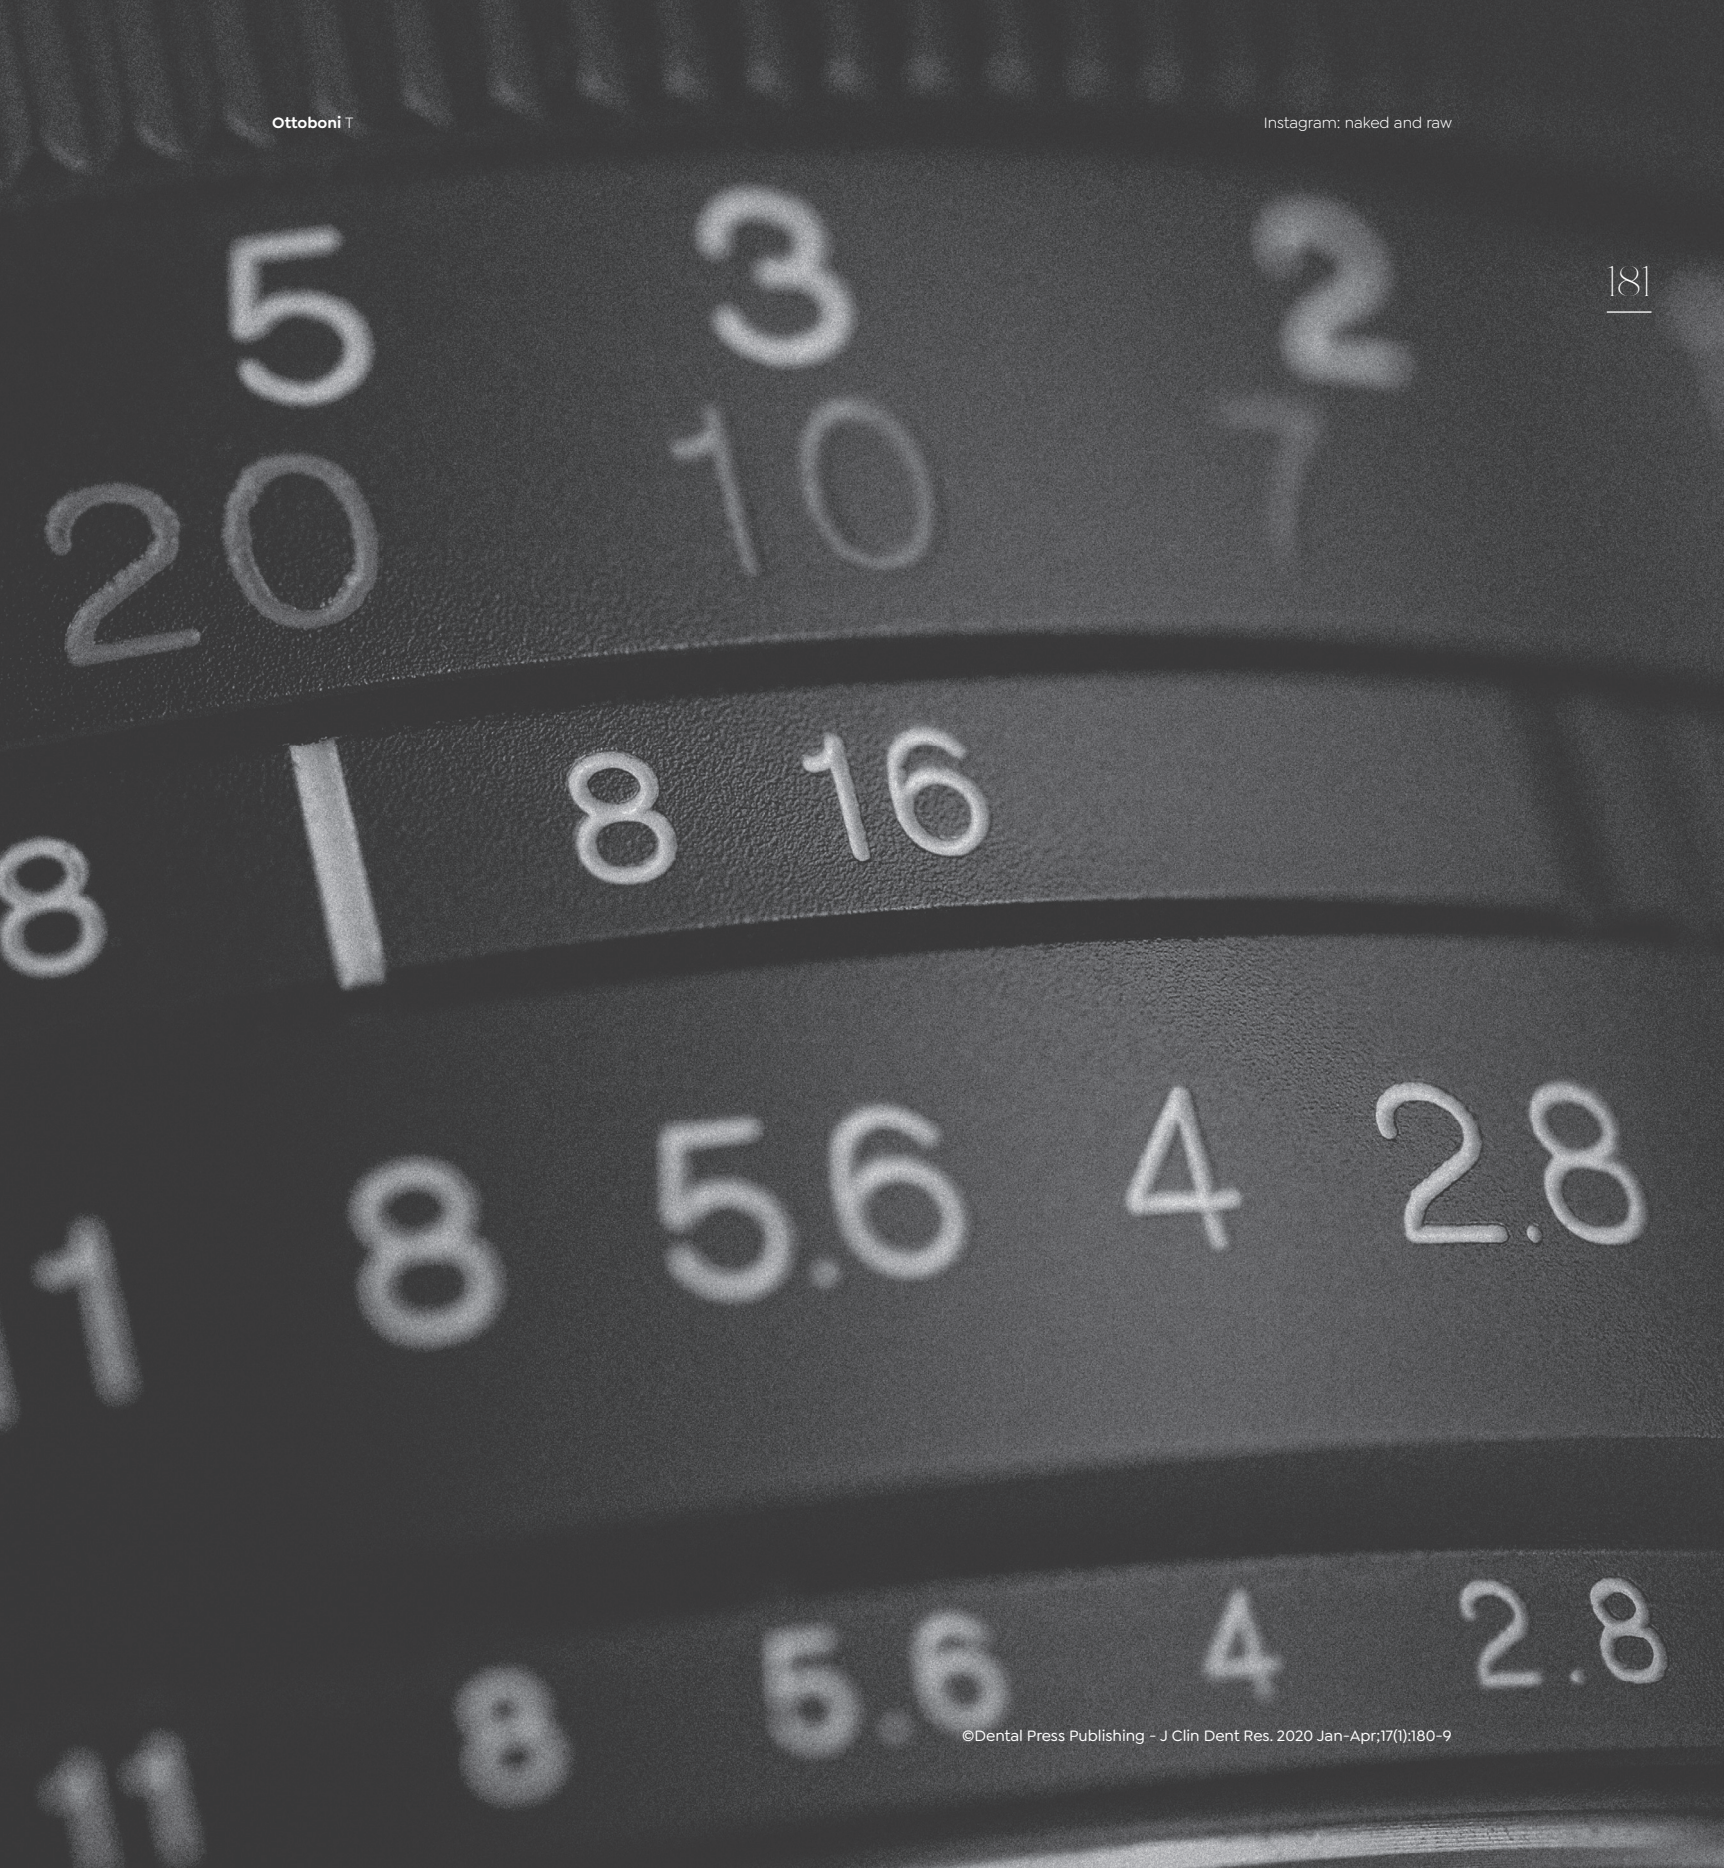
A woman presented with a complaint about the aesthetics of tooth #21. After clinical and radiographic examinations, we planned her treatment with a direct composite veneer restoration.

The treatment sequence and planning of the preparation and performance steps are extremely important.

According to Galip Gurel, Marcelo Calamita and Christian Coachman, a mean 0.3 mm is required for a tooth color to improve one or two shades. Therefore, we used a #4142 diamond depth cutter of the same diameter (KG Sorensen, Cotia Brazil) to obtain a 0.5-mm preparation, and, after that, a #2135 F bur (KG Sorensen, Cotia, Brazil) to join the grooves. The result was a 0.6 to 0.7 mm preparation. At this point, a color-matching test was used to test color and thickness of the restoration before bonding. This test included the teeth that were still fully hydrated, as described in Chapter 6 of the book published by the Brazilian Society of Esthetic Dentistry (SBOE) in 2018. After checking the test result test and placing a rubber dam, we removed the veneer. The steps followed after dentin hybridization were:

1. An opaquer to improve the substrate (Composite System, White Dental, Styleitaliano).
2. A thin layer of Si2 dentin shade.
3. Blue and White pigments (Tokuyama, Encinitas, CA) for opaque halo and translucent effect.
4. A thin layer of E enamel shade (Composite System, White Dental Beauty, Styleitaliano).

Stratification, a simple process, was carried out with pigments, because the area available to work was limited by the minimum possible preparation in this case.

Note: If the veneer used in the color-matching test is removed without any fractures, we may finish and polish it and use the technique developed by Professor Newton Fahl Jr. and bond it with cement after its surface is adequately treated.

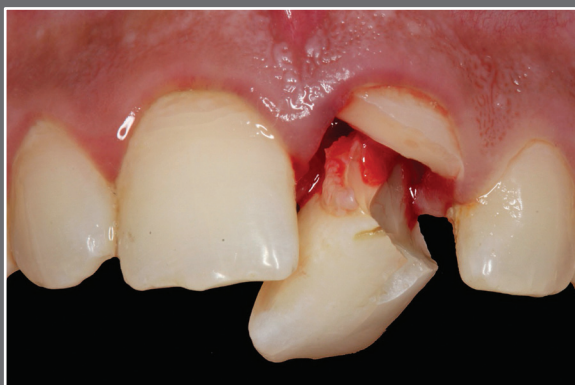
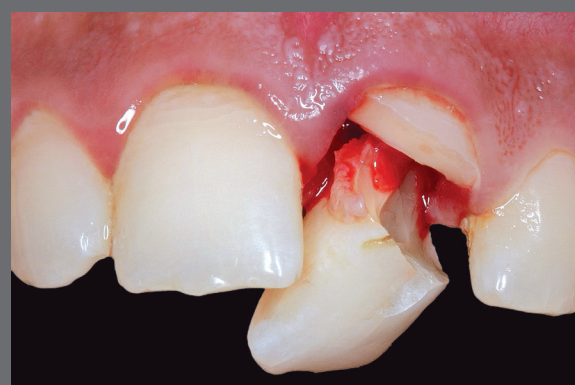
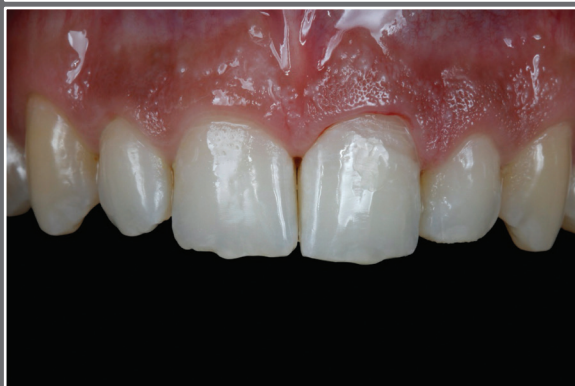
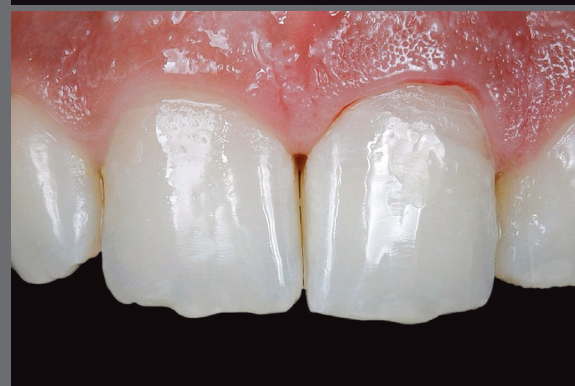
VICTOR CLAVIJO E ERIKA CLAVIJO**Clinical case**

A 30-year-old man was seen in the dental office because of trauma during sports practice. His tooth #21 had a crown and root fracture with pulp exposure.

In addition, the tooth appeared slightly elongated due to extrusive luxation. It had a viable remaining root fragment, and the root dimensions were good. On the palatal surface, the fracture was at the bone level. As the patient was a young adult and the tooth was in the aesthetic zone, and as some serious gingival and bone defects may develop if the tooth is extracted prematurely, we chose to try to keep it to “buy some time”.

Emergency visit procedures included rubber dam isolation, cleaning and disinfection of the root canal, application of calcium hydroxide as intracanal medication and provisionalization with a space maintainer. The tooth crown was kept in milk. In the second visit, four days later, the tooth was isolated again and then obturated. An endodontic insert (Helse Ultrasonic, Santa Rosa de Viterbo, Brazil) was used to cut gutta percha 6 mm below the buccal reference of tooth #21, which

was 14-mm long. After filling removal, the root canal underwent selective enamel etching using the self-etching Tetric N Bond Universal (Ivoclar Vivadent, Barueri, Brazil) adhesive. Adhesive excess was removed using a paper point, and then light cured for 60 s. The canal was filled with the Tetric N Flow composite, and the last canal filling layer was prepared with the IPS Empress Direct Dentina BLXL composite (Ivoclar Vivadent, Barueri, Brazil). The crown of the patient's tooth was cleaned, and an orifice was created inside it with a bur. Phosphoric acid and the adhesive were then used for etching, and the crown was later bonded with the IPS Empress Direct Dentina BLXL composite (Ivoclar Vivadent, Barueri, Brazil). After the rubber dam was removed, a suture was applied to the palatal surface, and occlusion was adjusted. After these procedures, the patient was referred to an orthodontic treatment using slow extrusion of the tooth to reestablish biologic width. The purpose of this procedure was to keep his tooth, which had an unclear prognosis, for as long as possible. This would preserve bone and the gingival architecture and ensure that the patient's aesthetic appearance was adequate for social life.

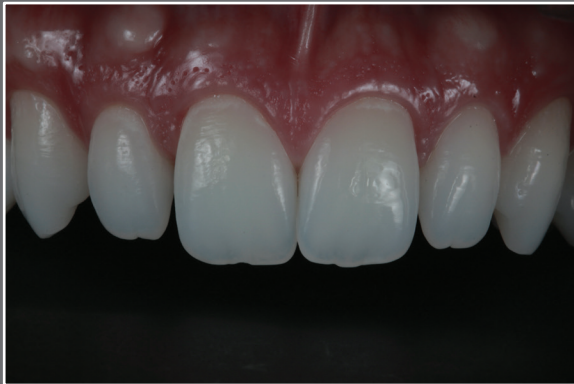
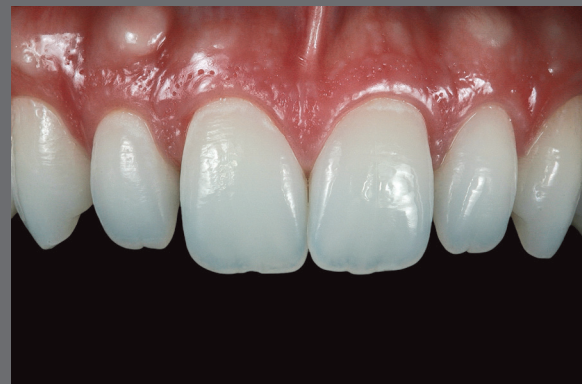
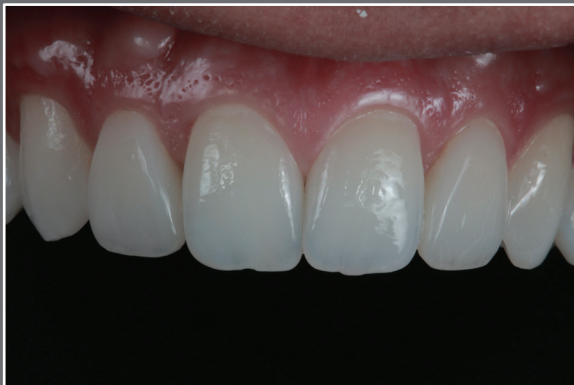
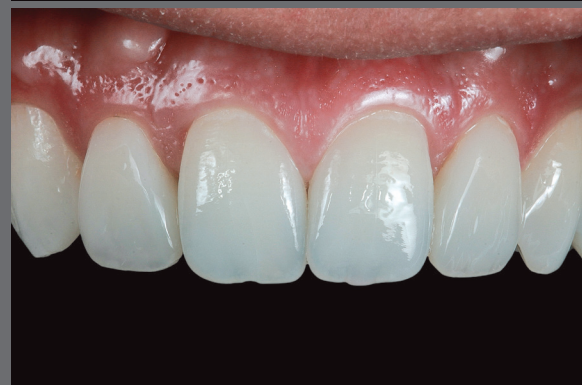
MARCUS PERILO

A patient came to our office to seek for aesthetic correction of conoid lateral incisors and diastemas with which he was unhappy.

After at-home whitening for 30 days, we took photos with a color scale and color map. We decided to follow the sequence below to prepare the composite veneers using the OMI Vita 3-D master shade:

1. XWE enamel shade (3M, Sumaré, Brazil) for the lingual surface.
2. WD (3M, Sumaré, Brazil) opaque halo.
3. CT (3M, Sumaré, Brazil) translucent halo.
4. XWB (3M, Sumaré, Brazil) for buccal and proximal surfaces.
5. XWE (3M, Sumaré, Brazil) for final buccal surface.

For polishing, we used course and medium Sof-Lex discs (3M, Sumaré, Brazil) and water, 12-bladed finishing burs (48L-010, Angelus, Londrina, Brazil), and silicone and diamond polishing spirals (3M, Sumaré, Brazil) with water.

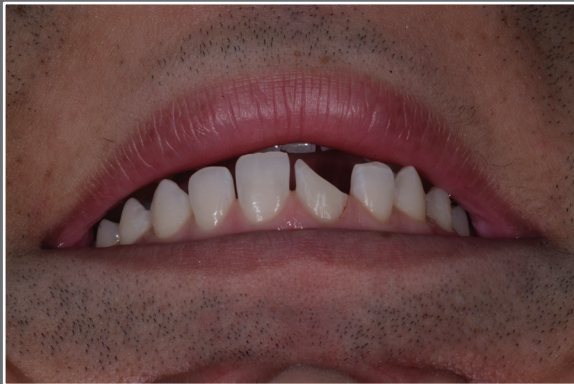
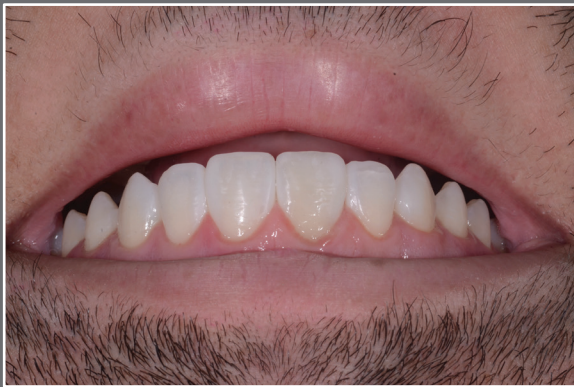
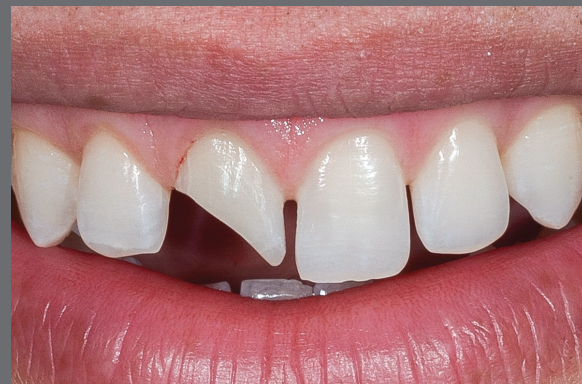
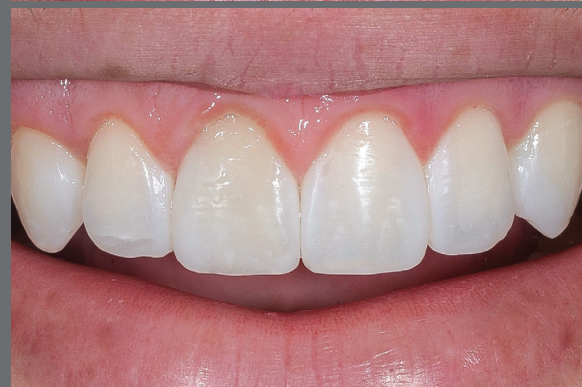
LEANDRO HILGERT

Patient presented with an aesthetic complaint about the color and shape of tooth #11 and diastemas. Ideal changes to his gingival level were discussed with the patient, who decided not to undergo those procedures at that time. Tooth #11 had an endodontic treatment and a large class IV restoration, and its color had a slightly lower value. The treatment included supervised at-home whitening with 10% carbamide peroxide (Whiteness Perfect, FGM, Joinville, Brazil), applied for 2 h to all teeth for three weeks and then only to tooth #11 for two additional weeks. The model was mounted in a semi-adjustable articulator and waxed, taking into consideration the patient's functional characteristics, such as anterior guidance and lateral excursion. Silicone mock-ups were prepared on the waxed model for the planned transference. Figure 1 shows the baseline conditions in the beginning of the restorative phase, after the removal of the restoration from tooth #11. There was no additional preparation. For this case, we

used a simplified nanoparticle composite system (Filtek Universal, 3M Oral Care, Sumaré, Brazil), with colors that have only one intermediate translucent shade, in addition to an opaquer.

In this case, classified in the broad class IV, the palatal wall of tooth #11 and the proximal surfaces were prepared using the XW shade. The central area of the fracture was filled with N AI composite, and the XW shade was again used on the buccal surface layer. Teeth #21, #22, #12, #23 and #33 received additions of the XW shade only. Finishing and polishing discs, a bladed finishing bur and rubber polishing spirals were used for finishing and polishing. Figure 2 shows photos of the clinical case two months after the treatment. Although this short and simplified restorative protocol used only two composite shades and one translucent composite, the result was satisfactory.
